Access Compliance Report

Public Rights-of-Way

(Curb Ramps)

Intersection ID: 14737	Main Street: CAMERON_AV	Cross Street: KENMORE_AV	Location: NE
ADA ID: 9CDE8060D49C	Ramp Type: PerpDiag	Initial Pass/Fail: Fail	Overall Compliance: No
		Severity Score: 37.5

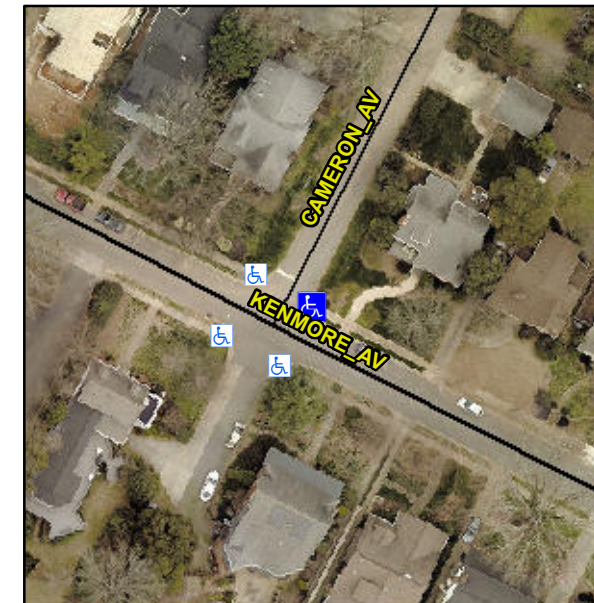
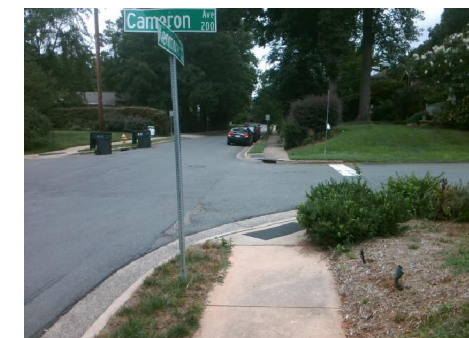
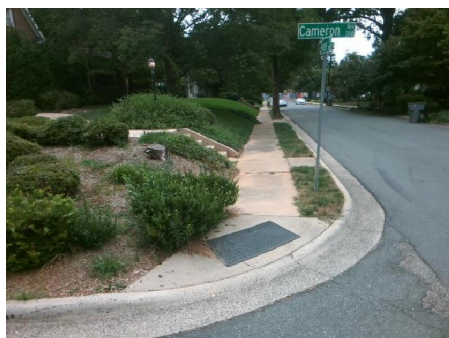
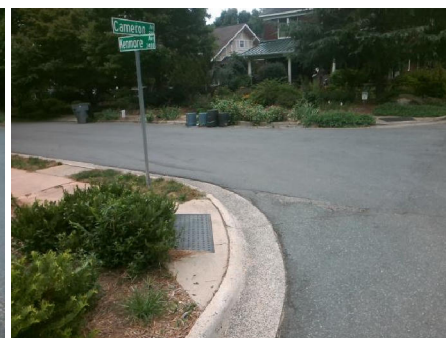
Not Found, R304.2.2, R304.5.3

Compliance	Description	Data	Compliance	Description	Data
N/A	Ramp Length (in)	35.0	No	Ramp Slope (%)	12.4
Yes	Ramp Width (in)	48.0	No	Ramp XSlope (%)	5.1
N/A	Flare Type LT	N/A	N/A	Flare Type RT	N/A
N/A	Flare Slope LT (%)	N/A	N/A	Flare Slope RT (%)	N/A
N/A	Flare Traversable LT?	N/A	N/A	Flare Traversable RT?	N/A
N/A	Landing Length (in)	N/A	N/A	DWS Provided?	N/A
N/A	Landing Width (in)	N/A	N/A	DWS Contrast?	N/A
N/A	Landing Slope (%)	N/A	N/A	DWS Length (in)	N/A
N/A	Landing X Slope (%)	N/A	N/A	DWS Full Width?	N/A
N/A	Landing Curb? (Y/N)	N/A	N/A	DWS Offset (in)	N/A
N/A	Shared Landing?	N/A			
N/A	Gutter Ponding?	N/A	N/A	Gutter Slope (%)	N/A
N/A	Gutter Lip Ht (in)	N/A	N/A	Gutter X Slope (%)	N/A
N/A	Painted X Walk1?	No	N/A	Painted X Walk2?	No
	X Walk 1 Direction	To NW		X Walk 2 Direction	To SW
N/A	X Walk 1 Width (in)	N/A	N/A	X Walk 2 Width (in)	N/A
	X Walk 1 Slope (%)	3.7		X Walk 2 Slope (%)	2.7
	X Walk 1 X Slope (%)	3.1		X Walk 2 X Slope (%)	4.6

N/A	Ramp inside XWalk1?	N/A	N/A	Ramp inside XWalk2?	N/A
	Road Slope (%)	4.9	N/A	Clear Space?	N/A
	Road X Slope (%)	6.0	N/A	Clear Space to XWalk (in)	N/A
N/A	Any Obstructions?	N/A	N/A	Storm Grate/Utility Hazard?	N/A
	Obstruction Type			Storm Grate/Utility Type	
		N/A			N/A
			Yes	Surface Condition? (G/P)	Good

Remove & Replace Curb Ramp With Two New Directional Ramps or Equivalent.
