| Intersection ID: 16452 | Main Street: STANFORD_PL | Cross Street: WELLESLEY_AV | Location: | E |
| ADA ID: 9CE7D0A13317 | Ramp Type: PerpDiag | Initial Pass/Fail: Pass | Overall Compliance: No | Severity Score: 15.25 |

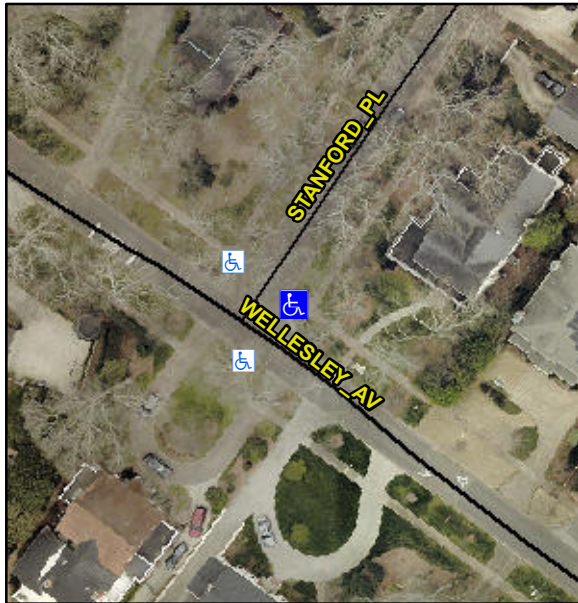
**Not Found, R304.5.3, R305, R304.5.4**

| Compliance | Description | Data | Compliance | Description | Data |
|---|---|---|---|---|---|
| N/A | Ramp Length (in) | 61.5 | Yes | Ramp Slope (%) | 7.0 |
| Yes | Ramp Width (in) | 58.0 | No | Ramp XSlope (%) | 3.4 |
| Yes | Landing Length (in) | 52.5 | No | DWS Provided? | No |
| No | Landing X Slope (%) | 2.8 | N/A | DWS Full Width? | No |
| Yes | Gutter Ponding? | No | No | Gutter Slope (%) | 5.2 |

**Remove & Replace Curb Ramp With Two New Directional Ramps or Equivalent. Remove & Replace Gutter.**
