Access Compliance Report

Public Rights-of-Way

(Curb Ramps)

Intersection ID: 11431	Main Street: N_GRAHAM_ST	Cross Street: W_9TH_ST	Location: N
ADA ID: 9CECDF45DDAB	Ramp Type: PerpDiag	Initial Pass/Fail: Pass	Overall Compliance: No
Severity Score: 5			
Codes/Mitigation Info/Possible Solution		Field Measurements/Component Compliance

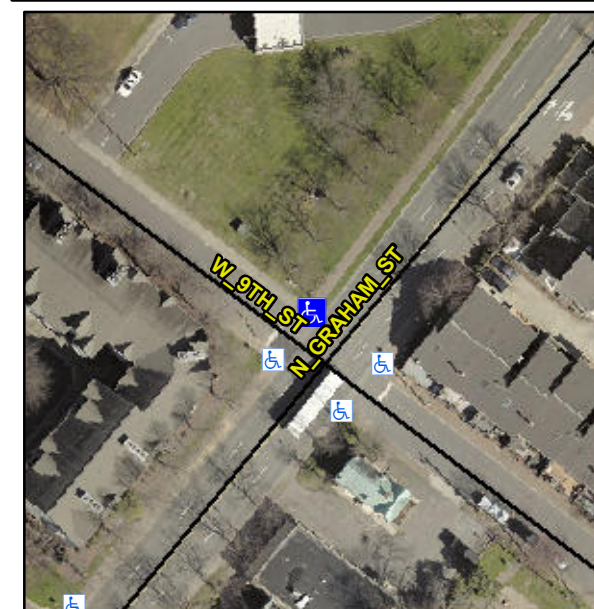
Compliance	Description	Data	Compliance	Description	Data
N/A	Ramp Length (in)	57.0	Yes	Ramp Slope (%)	8.0
Yes	Ramp Width (in)	48.0	Yes	Ramp XSlope (%)	1.9
N/A	Flare Type LT	Sloped	N/A	Flare Type RT	N/A
N/A	Flare Slope LT (%)	6.3	Yes	Flare Slope RT (%)	7.1
N/A	Flare Traversable LT?	Yes	N/A	Flare Traversable RT?	Yes
Yes	Landing Length (in)	60.0	Yes	DWS Provided?	Yes
Yes	Landing Width (in)	73.0	Yes	DWS Contrast?	Yes
Yes	Landing Slope (%)	0.1	Yes	DWS Length (in)	24.0
Yes	Landing X Slope (%)	1.6	Yes	DWS Full Width?	Yes
N/A	Landing Curb? (Y/N)	No	No	DWS Offset (in)	6.0
N/A	Shared Landing?	No			
Yes	Gutter Ponding?	No	No	Gutter Slope (%)	7.8
Yes	Gutter Lip Ht (in)	0.0	Yes	Gutter X Slope (%)	1.9
N/A	Painted X Walk1?	No	N/A	Painted X Walk2?	No
	X Walk 1 Direction	To SW		X Walk 2 Direction	To SE
N/A	X Walk 1 Width (in)	N/A	N/A	X Walk 2 Width (in)	N/A
	X Walk 1 Slope (%)	5.5		X Walk 2 Slope (%)	3.5
	X Walk 1 X Slope (%)	1.6		X Walk 2 X Slope (%)	0.2

N/A	Ramp inside XWalk1?	N/A	N/A	Ramp inside XWalk2?	N/A
	Road Slope (%)	1.6	N/A	Clear Space?	Yes
	Road X Slope (%)	5.7	N/A	Clear Space to XWalk (in)	N/A
Yes	Any Obstructions?	No	Yes	Storm Grate/Utility Hazard?	No
	Obstruction Type			Storm Grate/Utility Type	
		N/A			N/A
			Yes	Surface Condition? (G/P)	Good

Remove & Replace Detectable Warning System. Remove & Replace Gutter.

R305.2, R304.5.4
