Access Compliance Report

Public Rights-of-Way

(Curb Ramps)

Intersection ID: 18391	Main Street: LYNBROOK_DR	Cross Street: RAMA_RD	Location: NW
ADA ID: 9D140A1BF27C	Ramp Type: PerpDiag	Initial Pass/Fail: Fail	Overall Compliance: No
		Severity Score: 25

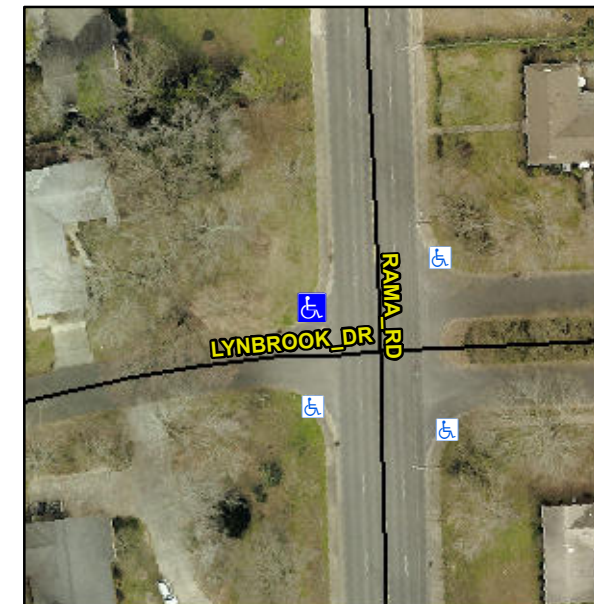
Not Found, R304.2.2, R304.5.3

Compliance	Description	Data	Compliance	Description	Data
N/A	Ramp Length (in)	60.0	No	Ramp Slope (%)	11.1
Yes	Ramp Width (in)	48.0	No	Ramp XSlope (%)	6.4
N/A	Flare Type LT	N/A	N/A	Flare Type RT	N/A
N/A	Flare Slope LT (%)	N/A	N/A	Flare Slope RT (%)	N/A
N/A	Flare Traversable LT?	N/A	N/A	Flare Traversable RT?	N/A
N/A	Landing Length (in)	N/A	N/A	DWS Provided?	N/A
N/A	Landing Width (in)	N/A	N/A	DWS Contrast?	N/A
N/A	Landing Slope (%)	N/A	N/A	DWS Length (in)	N/A
N/A	Landing X Slope (%)	N/A	N/A	DWS Full Width?	N/A
N/A	Landing Curb? (Y/N)	N/A	N/A	DWS Offset (in)	N/A
N/A	Shared Landing?	N/A			
N/A	Gutter Ponding?	N/A	N/A	Gutter Slope (%)	N/A
N/A	Gutter Lip Ht (in)	N/A	N/A	Gutter X Slope (%)	N/A
N/A	Painted X Walk1?	No	N/A	Painted X Walk2?	No
	X Walk 1 Direction	To SW		X Walk 2 Direction	To NE
N/A	X Walk 1 Width (in)	N/A	N/A	X Walk 2 Width (in)	N/A
	X Walk 1 Slope (%)	0.4		X Walk 2 Slope (%)	3.0
	X Walk 1 X Slope (%)	4.4		X Walk 2 X Slope (%)	0.7

N/A	Ramp inside XWalk1?	N/A	N/A	Ramp inside XWalk2?	N/A
	Road Slope (%)	3.8	N/A	Clear Space?	N/A
	Road X Slope (%)	3.5	N/A	Clear Space to XWalk (in)	N/A
N/A	Any Obstructions?	N/A	N/A	Storm Grate/Utility Hazard?	N/A
	Obstruction Type			Storm Grate/Utility Type	
		N/A			N/A
			Yes	Surface Condition? (G/P)	Good

Remove & Replace Curb Ramp With Two New Directional Ramps or Equivalent.
