# Access Compliance Report

## Public Rights-of-Way

### (Curb Ramps)

| Intersection ID: 14213 | Main Street: CENTRAL_AV | Cross Street: ROSEHAVEN_DR | Location: SW |

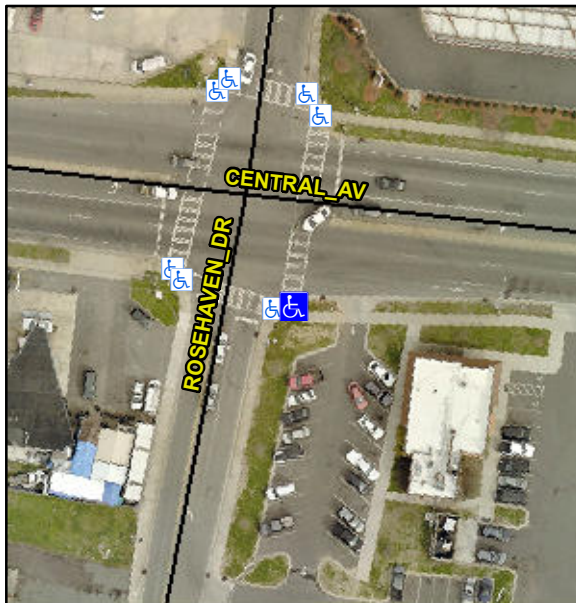
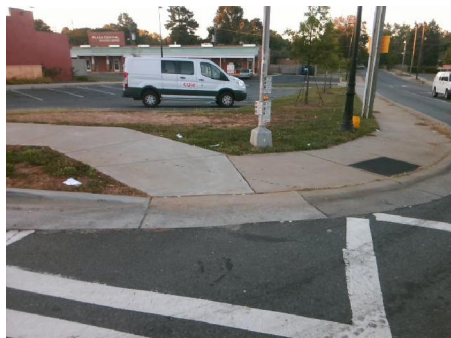
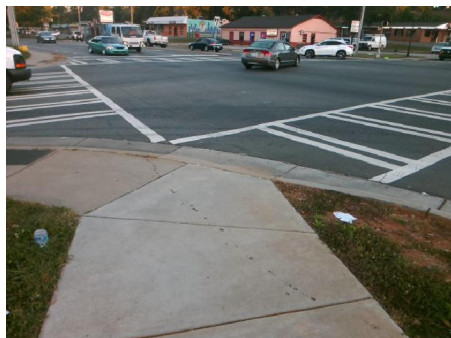
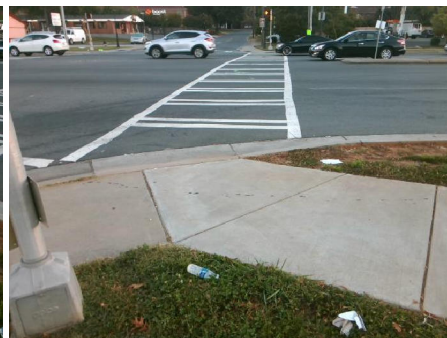
**Not Found, R304.5.3, R304.2.1,  
R304.2.2-Perp, R304.3.2-Para, R305**

| Compliance | Description | Data | Compliance | Description | Data |
|---|---|---|---|---|---|
| Yes | Ramp Width (in) | 49.0 | No | Ramp XSlope (%) | 4.5 |
| No | Landing Length (in) | 45.0 | No | DWS Provided? | No |
| No | Landing Slope (%) | 2.3 | N/A | DWS Length (in) | N/A |
| Yes | Gutter Lip Ht (in) | 0.0 | No | Gutter X Slope (%) | 2.6 |

Possible Solutions:

**Remove & Replace Entire Ramp.  
Remove & Replace Gutter.**
