Access Compliance Report

Public Rights-of-Way

(Curb Ramps)

Intersection ID: 31503	Main Street: CHARIDGE_LN	Cross Street: STONEY_PLACE_CT	Location: SE
ADA ID: 9D2245865537	Ramp Type: PerpDiag	Initial Pass/Fail: Fail	Overall Compliance: No
Severity Score: 22.5			
Codes/Mitigation Info/Possible Solution		Field Measurements/Component Compliance

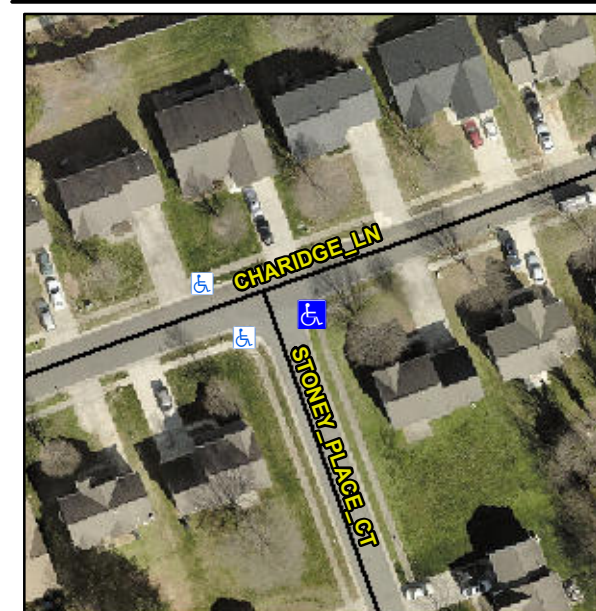
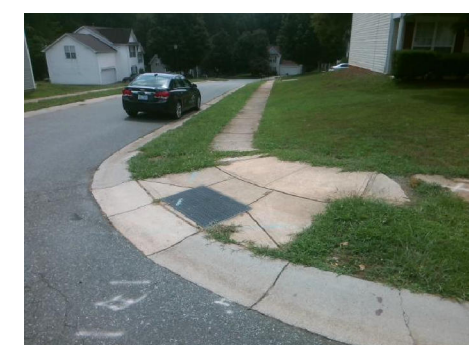
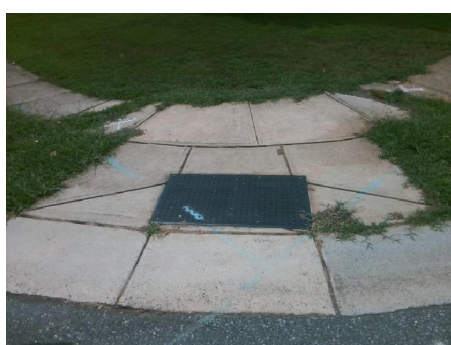
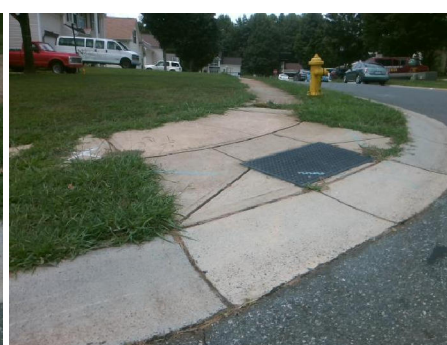
Not Found, R304.5.1, R304.2.2, R304.5.3

Compliance	Description	Data	Compliance	Description	Data
N/A	Ramp Length (in)	46.0	No	Ramp Slope (%)	9.1
No	Ramp Width (in)	36.0	No	Ramp XSlope (%)	3.5
N/A	Flare Type LT	N/A	N/A	Flare Type RT	N/A
N/A	Flare Slope LT (%)	N/A	N/A	Flare Slope RT (%)	N/A
N/A	Flare Traversable LT?	N/A	N/A	Flare Traversable RT?	N/A
N/A	Landing Length (in)	N/A	N/A	DWS Provided?	N/A
N/A	Landing Width (in)	N/A	N/A	DWS Contrast?	N/A
N/A	Landing Slope (%)	N/A	N/A	DWS Length (in)	N/A
N/A	Landing X Slope (%)	N/A	N/A	DWS Full Width?	N/A
N/A	Landing Curb? (Y/N)	N/A	N/A	DWS Offset (in)	N/A
N/A	Shared Landing?	N/A			
N/A	Gutter Ponding?	N/A	N/A	Gutter Slope (%)	N/A
N/A	Gutter Lip Ht (in)	N/A	N/A	Gutter X Slope (%)	N/A
N/A	Painted X Walk1?	No	N/A	Painted X Walk2?	No
	X Walk 1 Direction	To N		X Walk 2 Direction	To W
N/A	X Walk 1 Width (in)	N/A	N/A	X Walk 2 Width (in)	N/A
	X Walk 1 Slope (%)	2.0		X Walk 2 Slope (%)	4.9
	X Walk 1 X Slope (%)	5.5		X Walk 2 X Slope (%)	1.6

N/A	Ramp inside XWalk1?	N/A	N/A	Ramp inside XWalk2?	N/A
	Road Slope (%)	1.8	N/A	Clear Space?	N/A
	Road X Slope (%)	7.0	N/A	Clear Space to XWalk (in)	N/A
N/A	Any Obstructions?	N/A	N/A	Storm Grate/Utility Hazard?	N/A
	Obstruction Type			Storm Grate/Utility Type	
		N/A			N/A
			Yes	Surface Condition? (G/P)	Good

Remove & Replace Curb Ramp With Two New Directional Ramps or Equivalent.
