Access Compliance Report

Public Rights-of-Way

(Curb Ramps)

Intersection ID: 17926	Main Street: N_SHARON_AMITY_RD	Cross Street: RANDOLPH_RD	Location: SE
ADA ID: 9D2EE8174CF8	Ramp Type: PerpDiag	Initial Pass/Fail: Fail	Overall Compliance: No
Severity Score: 13.75			
Codes/Mitigation Info/Possible Solution		Field Measurements/Component Compliance

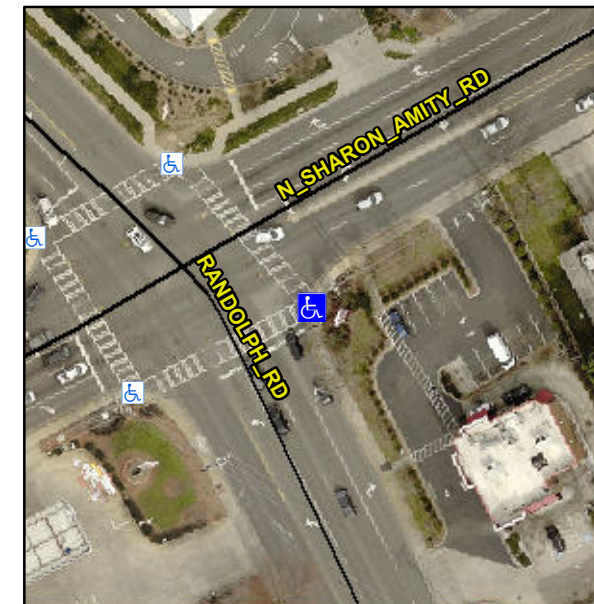
Compliance	Description	Data	Compliance	Description	Data
N/A	Ramp Length (in)	60.0	No	Ramp Slope (%)	8.7
Yes	Ramp Width (in)	48.0	No	Ramp XSlope (%)	3.5
N/A	Flare Type LT	N/A	N/A	Flare Type RT	N/A
N/A	Flare Slope LT (%)	N/A	N/A	Flare Slope RT (%)	N/A
N/A	Flare Traversable LT?	N/A	N/A	Flare Traversable RT?	N/A
N/A	Landing Length (in)	N/A	N/A	DWS Provided?	N/A
N/A	Landing Width (in)	N/A	N/A	DWS Contrast?	N/A
N/A	Landing Slope (%)	N/A	N/A	DWS Length (in)	N/A
N/A	Landing X Slope (%)	N/A	N/A	DWS Full Width?	N/A
N/A	Landing Curb? (Y/N)	N/A	N/A	DWS Offset (in)	N/A
N/A	Shared Landing?	N/A			
N/A	Gutter Ponding?	N/A	N/A	Gutter Slope (%)	N/A
N/A	Gutter Lip Ht (in)	1.0	N/A	Gutter X Slope (%)	N/A
N/A	Painted X Walk1?	Yes	N/A	Painted X Walk2?	Yes
	X Walk 1 Direction	To N		X Walk 2 Direction	To W
N/A	X Walk 1 Width (in)	111.0	N/A	X Walk 2 Width (in)	109.0
	X Walk 1 Slope (%)	1.2		X Walk 2 Slope (%)	1.1
	X Walk 1 X Slope (%)	1.3		X Walk 2 X Slope (%)	1.0

N/A	Ramp inside XWalk1?	Yes	N/A	Ramp inside XWalk2?	Yes
	Road Slope (%)	0.9	N/A	Clear Space?	N/A
	Road X Slope (%)	0.4	N/A	Clear Space to XWalk (in)	N/A
N/A	Any Obstructions?	N/A	N/A	Storm Grate/Utility Hazard?	N/A
	Obstruction Type			Storm Grate/Utility Type	
		N/A			N/A
		Yes		Surface Condition? (G/P)	Good

Possible Solutions:

Remove & Replace Curb Ramp With Two New Directional Ramps or Equivalent.
