# Access Compliance Report

## Public Rights-of-Way

### (Curb Ramps)

Intersection ID: 22200	Main Street: S_TRYON_ST	Cross Street: JOHN_PRICE_RD	Location: NE
ADA ID: 9D3CB1A59F26	Ramp Type: Perp	Initial Pass/Fail: Fail	Overall Compliance: No
			Severity Score: 26.25

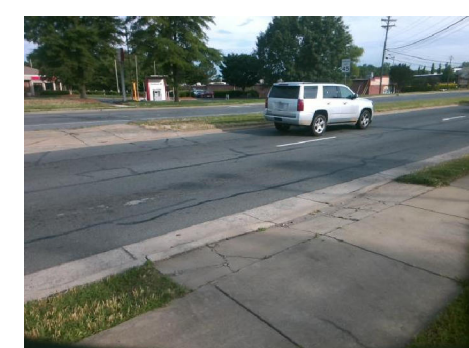
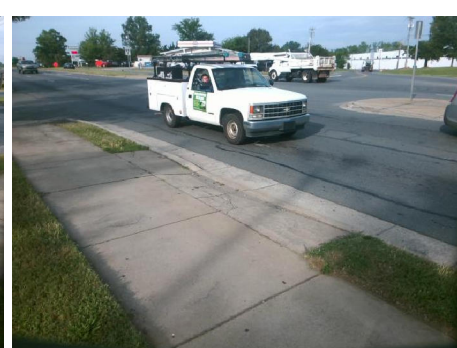
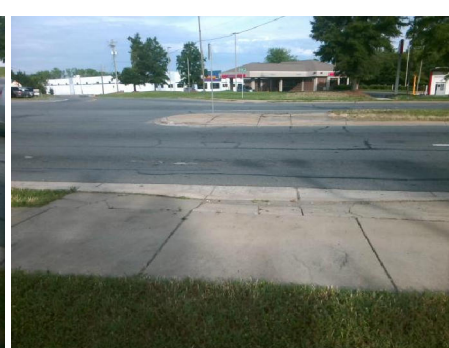
Possible Solutions:		<b>Compliance</b>	<b>Description</b>	<b>Data</b>
	<b>Remove &amp; Replace Entire Ramp.</b>		<b>No</b>	Ramp Length (in)	30.0
			<b>Yes</b>	Ramp Width (in)	48.0
			<b>N/A</b>	Flare Type LT	N/A
			<b>N/A</b>	Flare Slope LT (%)	N/A
			<b>N/A</b>	Flare Traversable LT?	N/A
			<b>N/A</b>	Landing Length (in)	N/A
			<b>N/A</b>	Landing Width (in)	N/A
			<b>N/A</b>	Landing Slope (%)	N/A
			<b>N/A</b>	Landing X Slope (%)	N/A
<p>Surveyor Notes:</p> <p><b>N/A</b></p> <p>PROW/ADA:</p> <p><b>Not Found, R304.2.2, R304.5.3</b></p>			<b>N/A</b>	Flare Type RT	N/A
			<b>N/A</b>	Flare Slope RT (%)	N/A
			<b>N/A</b>	Flare Traversable RT?	N/A
			<b>N/A</b>	DWS Provided?	N/A
			<b>N/A</b>	DWS Contrast?	N/A
			<b>N/A</b>	DWS Length (in)	N/A
			<b>N/A</b>	DWS Full Width?	N/A
			<b>N/A</b>	DWS Offset (in)	N/A
			<b>N/A</b>	Gutter Ponding?	N/A

<b>N/A</b>	Gutter Lip Ht (in)	N/A
			<b>No</b>	Painted X Walk1?	N/A
			<b>To W</b>	X Walk 1 Direction	N/A
			<b>N/A</b>	X Walk 1 Width (in)	N/A
			<b>0.7</b>	X Walk 1 Slope (%)	N/A
			<b>1.0</b>	X Walk 1 X Slope (%)	N/A
			<b>N/A</b>	Ramp inside XWalk1?	N/A
			<b>N/A</b>	Road Slope (%)	N/A
			<b>N/A</b>	Road X Slope (%)	N/A
			<b>N/A</b>	Any Obstructions?	N/A
				Obstruction Type	N/A
Total Cost: \$ 1850.00			<b>N/A</b>	Clear Space?	N/A
			<b>N/A</b>	Clear Space to XWalk (in)	N/A
			<b>N/A</b>	Storm Grate/Utility Hazard?	N/A
			<b>N/A</b>	Storm Grate/Utility Type	N/A
			<b>Yes</b>	Surface Condition? (G/P)	<b>Good</b>
