Access Compliance Report

Public Rights-of-Way

(Curb Ramps)

Intersection ID: 53380	Main Street: IKEA_BV	Cross Street: LEWIS_ST	Location:	N
ADA ID: 9D3ECA64141E	Ramp Type: Para	Initial Pass/Fail: Fail	Overall Compliance: No	Severity Score: 12.5
Codes/Mitigation Info/Possible Solution		Field Measurements/Component Compliance

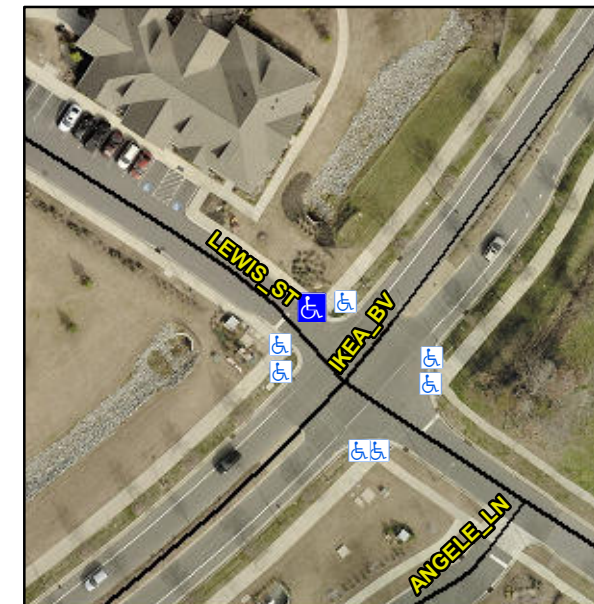
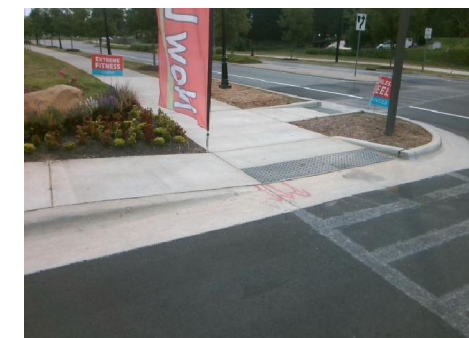
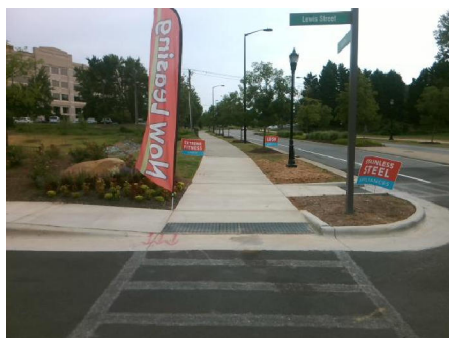
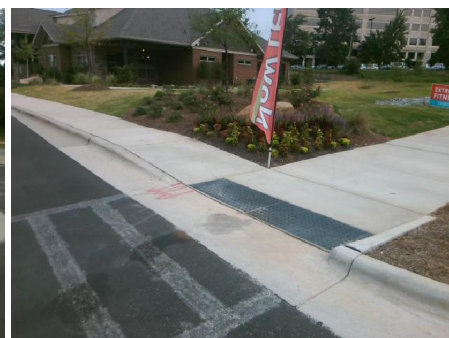
Compliance	Description	Data	Compliance	Description	Data
N/A	Ramp Length LT (in)	84.0	N/A	Ramp Length RT (in)	N/A
Yes	Ramp Width LT (in)	60.0	N/A	Ramp Width RT (in)	N/A
No	Ramp Slope LT (%)	9.8	N/A	Ramp Slope RT (%)	N/A
Yes	Ramp XSlope LT (%)	1.2	N/A	Ramp XSlope RT (%)	N/A
N/A	Landing Length (in)	N/A	N/A	DWS Provided?	N/A
N/A	Landing Width (in)	N/A	N/A	DWS Contrast?	N/A
N/A	Landing Slope (%)	N/A	N/A	DWS Length (in)	N/A
N/A	Landing X Slope (%)	N/A	N/A	DWS Full Width?	N/A
N/A	Landing Curb? (Y/N)	N/A	N/A	DWS Offset (in)	N/A
N/A	Shared Landing?	N/A			
N/A	Gutter Ponding?	N/A	N/A	Gutter Slope (%)	N/A
N/A	Gutter Lip Ht (in)	N/A	N/A	Gutter X Slope (%)	N/A
N/A	Painted X Walk1?	No	N/A	Painted X Walk2?	N/A
	X Walk 1 Direction	To SW		X Walk 2 Direction	N/A
N/A	X Walk 1 Width (in)	N/A	N/A	X Walk 2 Width (in)	N/A
	X Walk 1 Slope (%)	4.7		X Walk 2 Slope (%)	N/A
	X Walk 1 X Slope (%)	1.1		X Walk 2 X Slope (%)	N/A
N/A	Ramp inside XWalk1?	N/A	N/A	Ramp inside XWalk2?	N/A

Road Slope (%)	N/A	N/A	Clear Space?	N/A
	Road X Slope (%)	N/A	N/A	Clear Space to XWalk (in)	N/A
N/A	Any Obstructions?	N/A	N/A	Storm Grate/Utility Hazard?	N/A
	Obstruction Type			Storm Grate/Utility Type	
		N/A			N/A
			Yes	Surface Condition? (G/P)	Good
			N/A	Curb Slope (%)	N/A

Remove & Replace Entire Ramp.

R304.3.2
