Access Compliance Report

Public Rights-of-Way

(Curb Ramps)

Intersection ID: N/A	Main Street: TRYON_ST	Cross Street: MCDOWELL_FARMS_DR	Location: NE
ADA ID: 9D4B5F89E163	Ramp Type: Perp	Initial Pass/Fail: Fail	Overall Compliance: No
Severity Score: 12.5			
Codes/Mitigation Info/Possible Solution		Field Measurements/Component Compliance

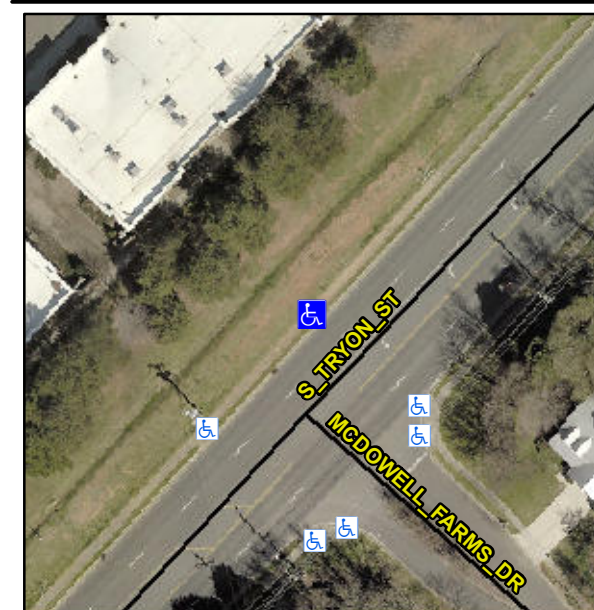
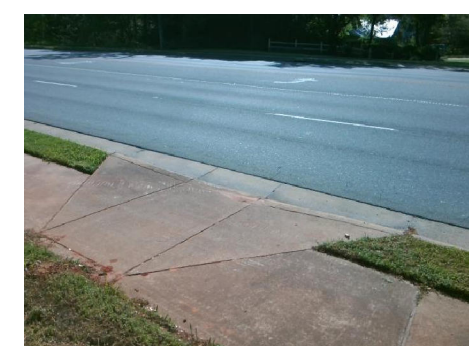
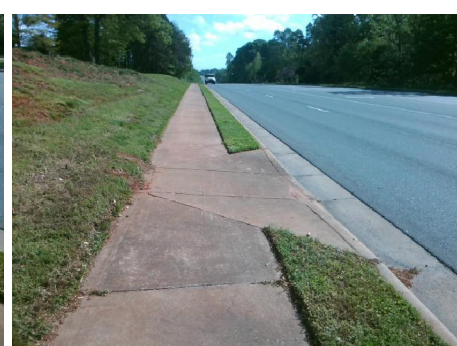
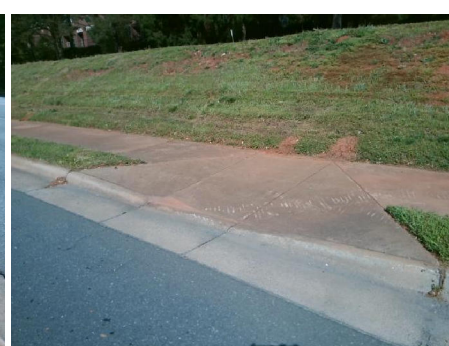
Compliance	Description	Data	Compliance	Description	Data
N/A	Ramp Length (in)	86.0	No	Ramp Slope (%)	9.1
Yes	Ramp Width (in)	49.0	Yes	Ramp XSlope (%)	1.4
N/A	Flare Type LT	N/A	N/A	Flare Type RT	N/A
N/A	Flare Slope LT (%)	N/A	N/A	Flare Slope RT (%)	N/A
N/A	Flare Traversable LT?	N/A	N/A	Flare Traversable RT?	N/A
N/A	Landing Length (in)	N/A	N/A	DWS Provided?	N/A
N/A	Landing Width (in)	N/A	N/A	DWS Contrast?	N/A
N/A	Landing Slope (%)	N/A	N/A	DWS Length (in)	N/A
N/A	Landing X Slope (%)	N/A	N/A	DWS Full Width?	N/A
N/A	Landing Curb? (Y/N)	N/A	N/A	DWS Offset (in)	N/A
N/A	Shared Landing?	N/A			
N/A	Gutter Ponding?	N/A	N/A	Gutter Slope (%)	N/A
N/A	Gutter Lip Ht (in)	1.0	N/A	Gutter X Slope (%)	N/A
N/A	Painted X Walk1?	No	N/A	Painted X Walk2?	N/A
	X Walk 1 Direction	To SE		X Walk 2 Direction	N/A
N/A	X Walk 1 Width (in)	N/A	N/A	X Walk 2 Width (in)	N/A
	X Walk 1 Slope (%)	2.8		X Walk 2 Slope (%)	N/A
	X Walk 1 X Slope (%)	0.5		X Walk 2 X Slope (%)	N/A

N/A	Ramp inside XWalk1?	N/A	N/A	Ramp inside XWalk2?	N/A
	Road Slope (%)	N/A	N/A	Clear Space?	N/A
	Road X Slope (%)	N/A	N/A	Clear Space to XWalk (in)	N/A
N/A	Any Obstructions?	N/A	N/A	Storm Grate/Utility Hazard?	N/A
	Obstruction Type			Storm Grate/Utility Type	
		N/A			N/A
			Yes	Surface Condition? (G/P)	Good

Possible Solutions:

Remove & Replace Entire Ramp.

R304.2.2

\$ 1850.00
