Access Compliance Report

Public Rights-of-Way

(Curb Ramps)

Intersection ID: 14938	Main Street: COLVILLE_RD	Cross Street: N_LAUREL_AV	Location: NW
ADA ID: 9D50B8FD852E	Ramp Type: Perp	Initial Pass/Fail: Fail	Overall Compliance: No
Severity Score: 25			
Codes/Mitigation Info/Possible Solution		Field Measurements/Component Compliance

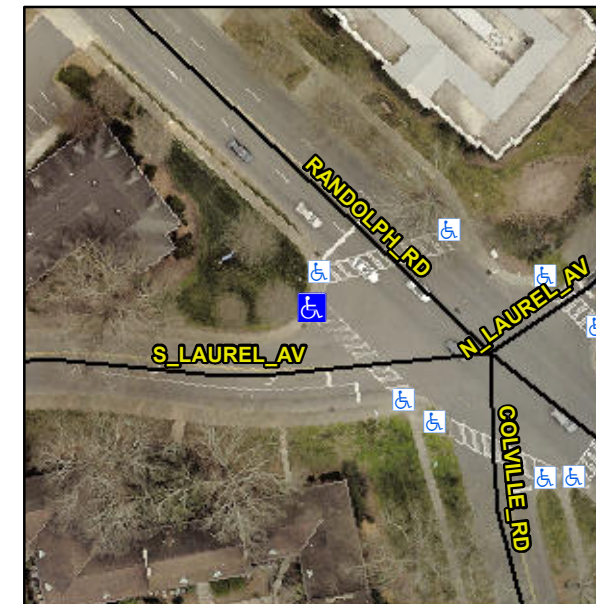
Not Found, R304.5.3

Compliance	Description	Data	Compliance	Description	Data
N/A	Ramp Length (in)	61.0	Yes	Ramp Slope (%)	6.9
Yes	Ramp Width (in)	48.0	No	Ramp XSlope (%)	11.1
N/A	Flare Type LT	N/A	N/A	Flare Type RT	N/A
N/A	Flare Slope LT (%)	N/A	N/A	Flare Slope RT (%)	N/A
N/A	Flare Traversable LT?	N/A	N/A	Flare Traversable RT?	N/A
N/A	Landing Length (in)	N/A	N/A	DWS Provided?	N/A
N/A	Landing Width (in)	N/A	N/A	DWS Contrast?	N/A
N/A	Landing Slope (%)	N/A	N/A	DWS Length (in)	N/A
N/A	Landing X Slope (%)	N/A	N/A	DWS Full Width?	N/A
N/A	Landing Curb? (Y/N)	N/A	N/A	DWS Offset (in)	N/A
N/A	Shared Landing?	N/A			
N/A	Gutter Ponding?	N/A	N/A	Gutter Slope (%)	N/A
N/A	Gutter Lip Ht (in)	N/A	N/A	Gutter X Slope (%)	N/A
N/A	Painted X Walk1?	Yes	N/A	Painted X Walk2?	N/A
	X Walk 1 Direction	To SE		X Walk 2 Direction	N/A
N/A	X Walk 1 Width (in)	122.0	N/A	X Walk 2 Width (in)	N/A
	X Walk 1 Slope (%)	0.1		X Walk 2 Slope (%)	N/A
	X Walk 1 X Slope (%)	9.2		X Walk 2 X Slope (%)	N/A

N/A	Ramp inside XWalk1?	Yes	N/A	Ramp inside XWalk2?	N/A
	Road Slope (%)	N/A	N/A	Clear Space?	N/A
	Road X Slope (%)	N/A	N/A	Clear Space to XWalk (in)	N/A
N/A	Any Obstructions?	N/A	N/A	Storm Grate/Utility Hazard?	N/A
	Obstruction Type			Storm Grate/Utility Type	
		N/A			N/A
		Yes		Surface Condition? (G/P)	Good

Possible Solutions:

Remove & Replace Entire Ramp.

Total Cost: \$ 1850.00
