Access Compliance Report

Public Rights-of-Way

(Curb Ramps)

Intersection ID: 44723	Main Street: PROSPERITY_CHURCH_RD	Cross Street: JOHNSTON_OEHLER_RD	Location: NE
ADA ID: 9D586B0B3B27	Ramp Type: Perp	Initial Pass/Fail: Fail	Overall Compliance: No
Severity Score: 10			
Codes/Mitigation Info/Possible Solution		Field Measurements/Component Compliance

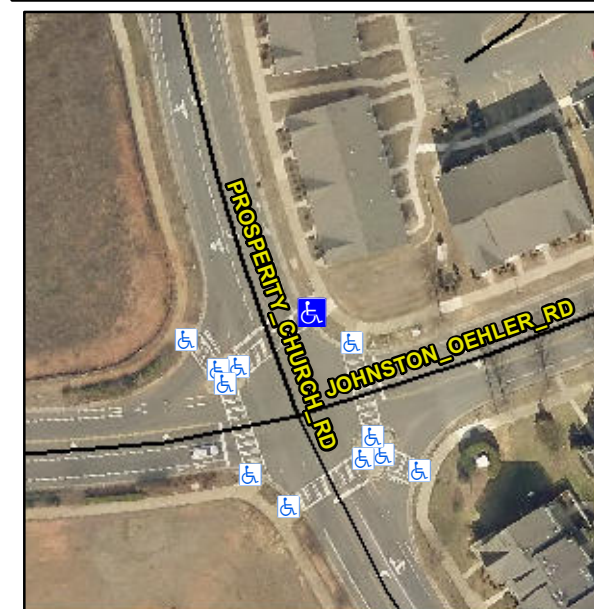
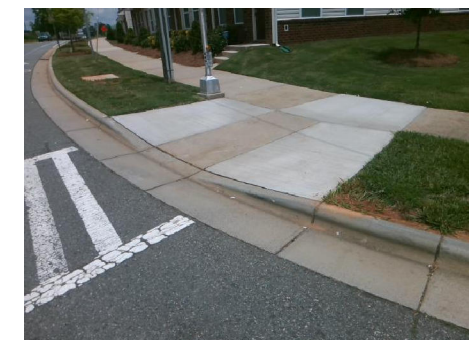
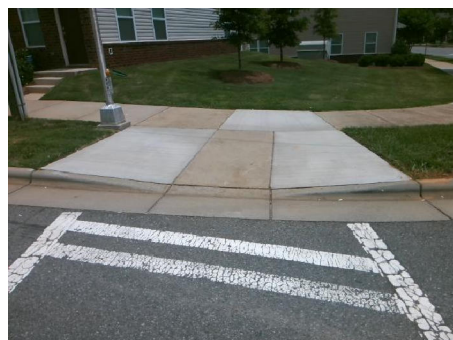
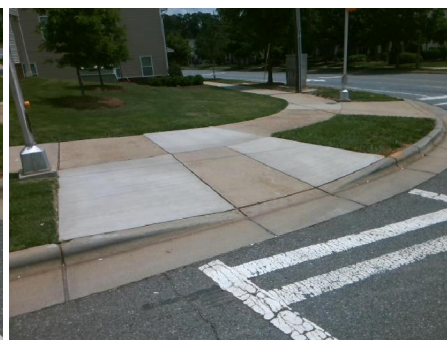
Compliance	Description	Data	Compliance	Description	Data
N/A	Ramp Length (in)	96.0	Yes	Ramp Slope (%)	5.3
No	Ramp Width (in)	41.0	No	Ramp XSlope (%)	4.4
N/A	Flare Type LT	N/A	N/A	Flare Type RT	N/A
N/A	Flare Slope LT (%)	N/A	N/A	Flare Slope RT (%)	N/A
N/A	Flare Traversable LT?	N/A	N/A	Flare Traversable RT?	N/A
N/A	Landing Length (in)	N/A	N/A	DWS Provided?	N/A
N/A	Landing Width (in)	N/A	N/A	DWS Contrast?	N/A
N/A	Landing Slope (%)	N/A	N/A	DWS Length (in)	N/A
N/A	Landing X Slope (%)	N/A	N/A	DWS Full Width?	N/A
N/A	Landing Curb? (Y/N)	N/A	N/A	DWS Offset (in)	N/A
N/A	Shared Landing?	N/A			
N/A	Gutter Ponding?	N/A	N/A	Gutter Slope (%)	N/A
N/A	Gutter Lip Ht (in)	N/A	N/A	Gutter X Slope (%)	N/A
N/A	Painted X Walk1?	Yes	N/A	Painted X Walk2?	N/A
	X Walk 1 Direction	To SW		X Walk 2 Direction	N/A
N/A	X Walk 1 Width (in)	108.0	N/A	X Walk 2 Width (in)	N/A
	X Walk 1 Slope (%)	0.9		X Walk 2 Slope (%)	N/A
	X Walk 1 X Slope (%)	2.7		X Walk 2 X Slope (%)	N/A

N/A	Ramp inside XWalk1?	Yes	N/A	Ramp inside XWalk2?	N/A
	Road Slope (%)	N/A	N/A	Clear Space?	N/A
	Road X Slope (%)	N/A	N/A	Clear Space to XWalk (in)	N/A
N/A	Any Obstructions?	N/A	N/A	Storm Grate/Utility Hazard?	N/A
	Obstruction Type			Storm Grate/Utility Type	
		N/A			N/A
			Yes	Surface Condition? (G/P)	Good

Possible Solutions:

Remove & Replace Entire Ramp.

R304.5.1, R304.5.3
