Access Compliance Report

Public Rights-of-Way

(Curb Ramps)

Intersection ID: 11730	Main Street: MECKLENBURG_AV	Cross Street: THE_PLAZA	Location: SE
ADA ID: 9D6247B5CD68	Ramp Type: BlendTrans1	Initial Pass/Fail: Fail	Overall Compliance: No
		Severity Score: 12.5

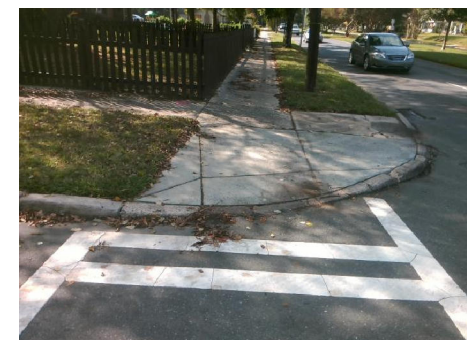
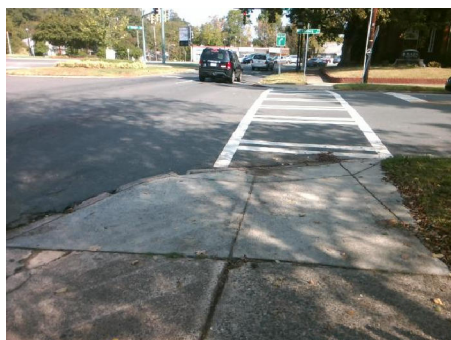
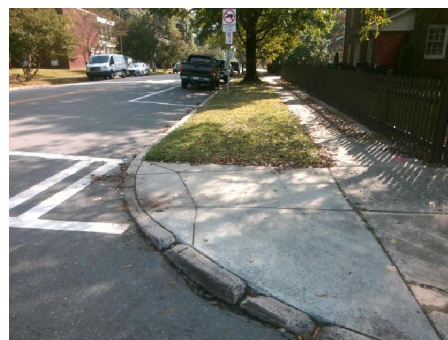
Compliance	Description	Data	Compliance	Description	Data
N/A	Ramp Length (in)	94.0	Yes	BlendTrans Slope (%)	3.8
Yes	Ramp Width (in)	52.0	No	BlendTrans XSlope (%)	5.8
N/A	Flare Type LT	N/A	N/A	Flare Type RT	N/A
N/A	Flare Slope LT (%)	N/A	N/A	Flare Slope RT (%)	N/A
N/A	Flare Traversable LT?	N/A	N/A	Flare Traversable RT?	N/A
N/A	Landing Length (in)	N/A	N/A	DWS Provided?	N/A
N/A	Landing Width (in)	N/A	N/A	DWS Contrast?	N/A
N/A	Landing Slope (%)	N/A	N/A	DWS Length (in)	N/A
N/A	Landing X Slope (%)	N/A	N/A	DWS Full Width?	N/A
N/A	Landing Curb? (Y/N)	N/A	N/A	DWS Offset (in)	N/A
N/A	Shared Landing?	N/A			
N/A	Gutter Ponding?	Yes	N/A	Gutter Slope (%)	N/A
N/A	Gutter Lip Ht (in)	N/A	N/A	Gutter X Slope (%)	N/A
N/A	Painted X Walk1?	Yes	N/A	Painted X Walk2?	N/A
	X Walk 1 Direction	To N		X Walk 2 Direction	N/A
	X Walk 1 Width (in)	85.0		X Walk 2 Width (in)	N/A
	X Walk 1 Slope (%)	6.1		X Walk 2 Slope (%)	N/A
	X Walk 1 X Slope (%)	0.1		X Walk 2 X Slope (%)	N/A

N/A	Ramp inside XWalk1?	Yes	N/A	Ramp inside XWalk2?	N/A
	Road Slope (%)	0.1		Clear Space?	N/A
	Road X Slope (%)	6.1	N/A	Clear Space to XWalk (in)	N/A
N/A	Any Obstructions?	N/A	N/A	Storm Grate/Utility Hazard?	N/A
	Obstruction Type			Storm Grate/Utility Type	
		N/A			N/A
			Yes	Surface Condition? (G/P)	Good
			N/A	Curb Slope (%)	2.2

Remove & Replace Curb Ramp With Two New Directional Ramps or Equivalent.

R304.5.3
