# Access Compliance Report

## Public Rights-of-Way

### (Curb Ramps)

| Intersection ID: 10795 | Main Street: CLEMSON_AV | Cross Street: MATHESON_AV | Location: SE |

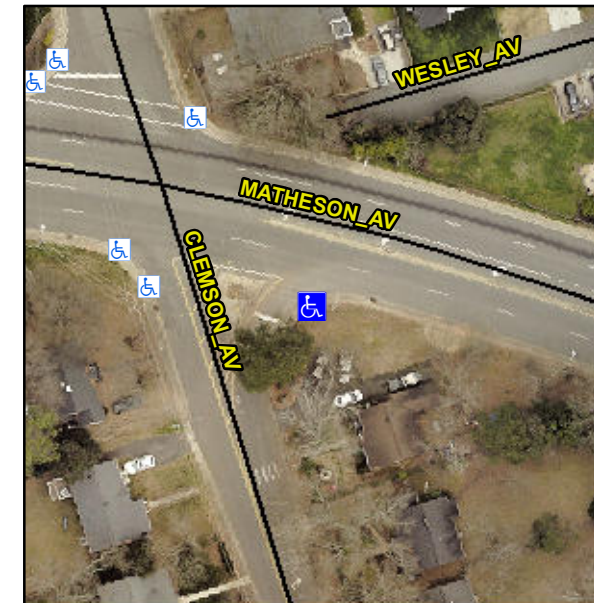
**Not Found, R304.5.1, R304.2.2, R304.5.3**

| Compliance | Description | Data | Compliance | Description | Data |
|---|---|---|---|---|---|
| N/A | Ramp Length (in) | 28.5 | No | Ramp Slope (%) | 8.4 |
| No | Ramp Width (in) | 46.0 | No | Ramp XSlope (%) | 4.8 |

**Remove & Replace Entire Ramp.**

Total Cost: \$ 1850.00
