# Access Compliance Report

## Public Rights-of-Way

### (Curb Ramps)

Intersection ID: 48394	Main Street: RICHARD_ROZZELLE_DR	Cross Street: SUSANNA_DR	Location:	N
ADA ID: 9D73A768DE03	Ramp Type: Perp	Initial Pass/Fail: Fail	Overall Compliance: No	Severity Score: 10
Codes/Mitigation Info/Possible Solution		Field Measurements/Component Compliance

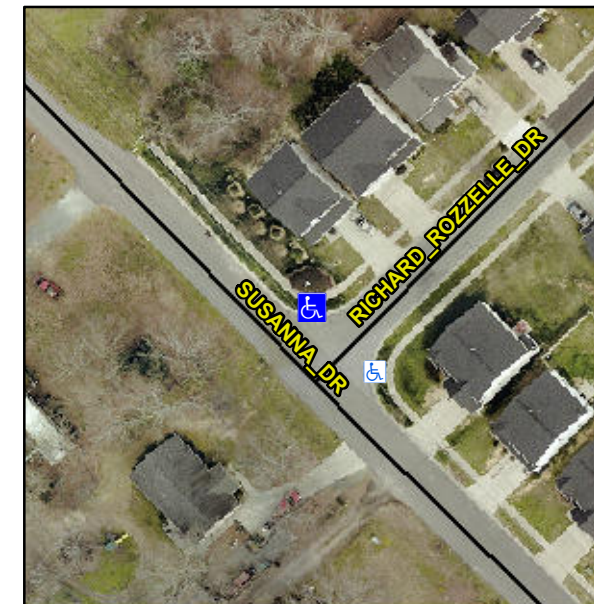
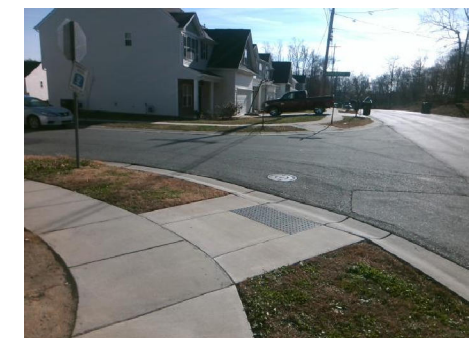
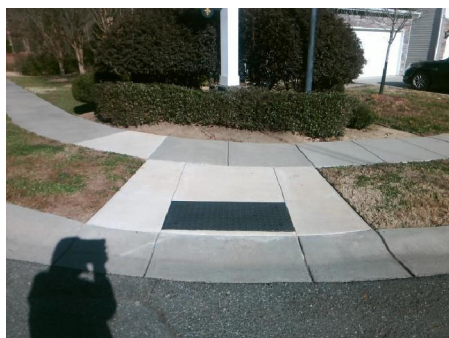
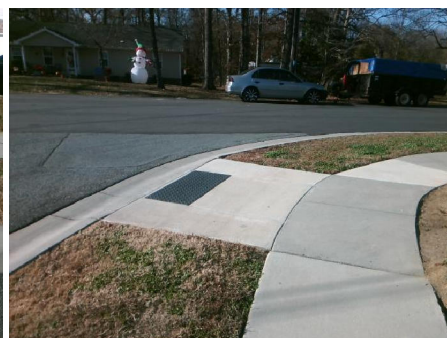
**Not Found, R304.5.1, R304.5.3**

Compliance	Description	Data	Compliance	Description	Data
N/A	Ramp Length (in)	72.0	Yes	Ramp Slope (%)	5.0
No	Ramp Width (in)	47.5	No	Ramp XSlope (%)	2.8
N/A	Flare Type LT	N/A	N/A	Flare Type RT	N/A
N/A	Flare Slope LT (%)	N/A	N/A	Flare Slope RT (%)	N/A
N/A	Flare Traversable LT?	N/A	N/A	Flare Traversable RT?	N/A
N/A	Landing Length (in)	N/A	N/A	DWS Provided?	N/A
N/A	Landing Width (in)	N/A	N/A	DWS Contrast?	N/A
N/A	Landing Slope (%)	N/A	N/A	DWS Length (in)	N/A
N/A	Landing X Slope (%)	N/A	N/A	DWS Full Width?	N/A
N/A	Landing Curb? (Y/N)	N/A	N/A	DWS Offset (in)	N/A
N/A	Shared Landing?	N/A			
N/A	Gutter Ponding?	N/A	N/A	Gutter Slope (%)	N/A
N/A	Gutter Lip Ht (in)	N/A	N/A	Gutter X Slope (%)	N/A
N/A	Painted X Walk1?	No	N/A	Painted X Walk2?	N/A
	X Walk 1 Direction	To SE		X Walk 2 Direction	N/A
N/A	X Walk 1 Width (in)	N/A	N/A	X Walk 2 Width (in)	N/A
	X Walk 1 Slope (%)	2.3		X Walk 2 Slope (%)	N/A
	X Walk 1 X Slope (%)	2.1		X Walk 2 X Slope (%)	N/A

N/A	Ramp inside XWalk1?	N/A	N/A	Ramp inside XWalk2?	N/A
	Road Slope (%)	N/A	N/A	Clear Space?	N/A
	Road X Slope (%)	N/A	N/A	Clear Space to XWalk (in)	N/A
N/A	Any Obstructions?	N/A	N/A	Storm Grate/Utility Hazard?	N/A
	Obstruction Type			Storm Grate/Utility Type	
		N/A			N/A
			Yes	Surface Condition? (G/P)	Good

**Remove & Replace Entire Ramp.**
