Access Compliance Report

Public Rights-of-Way

(Curb Ramps)

Intersection ID: 45777	Main Street: SUGARBUSH_DR	Cross Street: CARVER_FALLS_RD	Location: E
ADA ID: 9D838F3CAC9B	Ramp Type: BlendTrans1	Initial Pass/Fail: Fail	Overall Compliance: No
Severity Score: 21.25			
Codes/Mitigation Info/Possible Solution		Field Measurements/Component Compliance

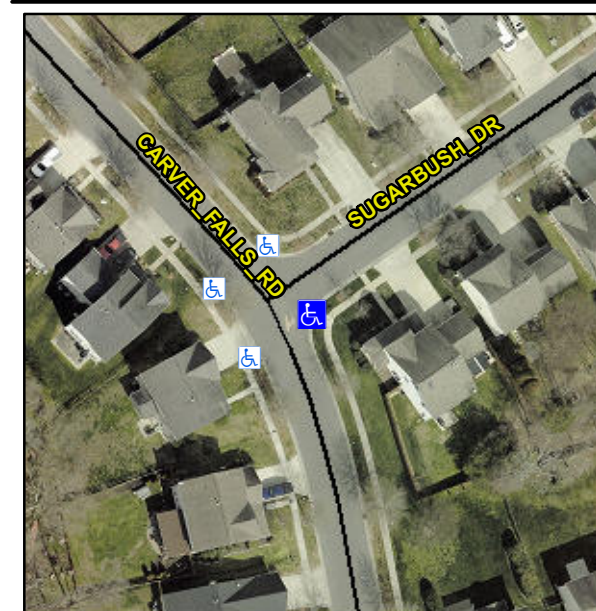
Compliance	Description	Data	Compliance	Description	Data
N/A	Ramp Length (in)	73.0	Yes	BlendTrans Slope (%)	2.6
No	Ramp Width (in)	46.0	No	BlendTrans XSlope (%)	6.6
N/A	Flare Type LT	N/A	N/A	Flare Type RT	N/A
N/A	Flare Slope LT (%)	N/A	N/A	Flare Slope RT (%)	N/A
N/A	Flare Traversable LT?	N/A	N/A	Flare Traversable RT?	N/A
N/A	Landing Length (in)	N/A	N/A	DWS Provided?	N/A
N/A	Landing Width (in)	N/A	N/A	DWS Contrast?	N/A
N/A	Landing Slope (%)	N/A	N/A	DWS Length (in)	N/A
N/A	Landing X Slope (%)	N/A	N/A	DWS Full Width?	N/A
N/A	Landing Curb? (Y/N)	N/A	N/A	DWS Offset (in)	N/A
N/A	Shared Landing?	N/A			
N/A	Gutter Ponding?	N/A	N/A	Gutter Slope (%)	N/A
N/A	Gutter Lip Ht (in)	N/A	N/A	Gutter X Slope (%)	N/A
N/A	Painted X Walk1?	No	N/A	Painted X Walk2?	No
	X Walk 1 Direction	To NW		X Walk 2 Direction	To SW
	X Walk 1 Width (in)	N/A		X Walk 2 Width (in)	N/A
	X Walk 1 Slope (%)	2.8		X Walk 2 Slope (%)	0.5
	X Walk 1 X Slope (%)	4.0		X Walk 2 X Slope (%)	4.6

N/A	Ramp inside XWalk1?	N/A	N/A	Ramp inside XWalk2?	N/A
	Road Slope (%)	5.2		Clear Space?	N/A
	Road X Slope (%)	0.8	N/A	Clear Space to XWalk (in)	N/A
N/A	Any Obstructions?	N/A	N/A	Storm Grate/Utility Hazard?	N/A
	Obstruction Type			Storm Grate/Utility Type	
		N/A			N/A
			Yes	Surface Condition? (G/P)	Good
			N/A	Curb Slope (%)	2.5

Possible Solutions:

Remove & Replace Curb Ramp With Two New Directional Ramps or Equivalent.

R304.5.1, R304.5.3
