Access Compliance Report

Public Rights-of-Way

(Curb Ramps)

Intersection ID: 10021978	Main Street: BROOKSVALE_ST	Cross Street: N/A	Location: NE
ADA ID: 9D95B8DC0309	Ramp Type: Perp	Initial Pass/Fail: Fail	Overall Compliance: No
		Severity Score: 12.5

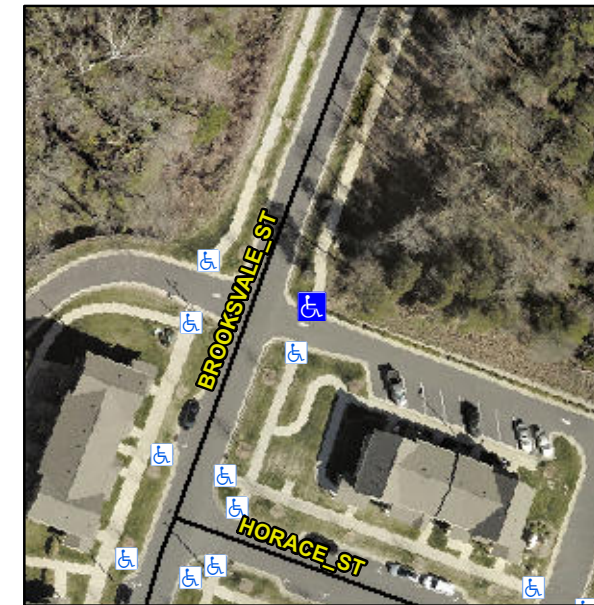
Not Found, R304.2.2

Compliance	Description	Data	Compliance	Description	Data
N/A	Ramp Length (in)	68.0	No	Ramp Slope (%)	8.6
Yes	Ramp Width (in)	71.0	Yes	Ramp XSlope (%)	0.4
N/A	Flare Type LT	N/A	N/A	Flare Type RT	N/A
N/A	Flare Slope LT (%)	N/A	N/A	Flare Slope RT (%)	N/A
N/A	Flare Traversable LT?	N/A	N/A	Flare Traversable RT?	N/A
N/A	Landing Length (in)	N/A	N/A	DWS Provided?	N/A
N/A	Landing Width (in)	N/A	N/A	DWS Contrast?	N/A
N/A	Landing Slope (%)	N/A	N/A	DWS Length (in)	N/A
N/A	Landing X Slope (%)	N/A	N/A	DWS Full Width?	N/A
N/A	Landing Curb? (Y/N)	N/A	N/A	DWS Offset (in)	N/A
N/A	Shared Landing?	N/A			
N/A	Gutter Ponding?	N/A	N/A	Gutter Slope (%)	N/A
N/A	Gutter Lip Ht (in)	N/A	N/A	Gutter X Slope (%)	N/A
N/A	Painted X Walk1?	No	N/A	Painted X Walk2?	N/A
	X Walk 1 Direction	To SW		X Walk 2 Direction	N/A
N/A	X Walk 1 Width (in)	N/A	N/A	X Walk 2 Width (in)	N/A
	X Walk 1 Slope (%)	0.2		X Walk 2 Slope (%)	N/A
	X Walk 1 X Slope (%)	3.2		X Walk 2 X Slope (%)	N/A

Remove & Replace Entire Ramp.

Total Cost: \$ 1850.00

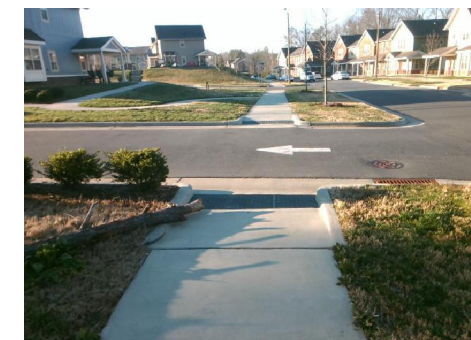
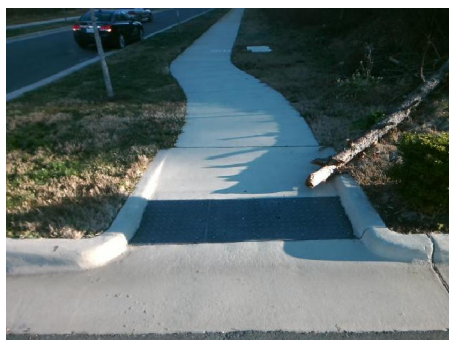
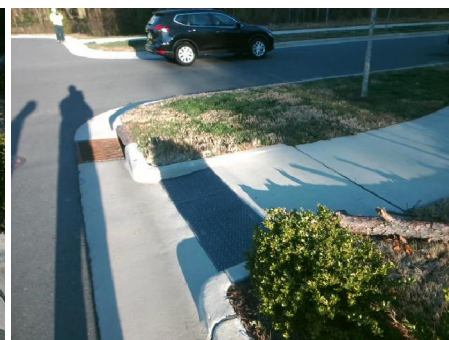
N/A	Ramp inside XWalk1?	N/A	N/A	Ramp inside XWalk2?	N/A
	Road Slope (%)	N/A	N/A	Clear Space?	N/A
	Road X Slope (%)	N/A	N/A	Clear Space to XWalk (in)	N/A
N/A	Any Obstructions?	N/A	N/A	Storm Grate/Utility Hazard?	N/A
	Obstruction Type			Storm Grate/Utility Type	
		N/A			N/A
			Yes	Surface Condition? (G/P)	Good
