Access Compliance Report

Public Rights-of-Way

(Curb Ramps)

Intersection ID: 23437	Main Street: MOSS_RD	Cross Street: S_TRYON_ST	Location: NW
ADA ID: 9D9DA74D5700	Ramp Type: Perp	Initial Pass/Fail: Fail	Overall Compliance: No
Severity Score: 21.25			
Codes/Mitigation Info/Possible Solution		Field Measurements/Component Compliance

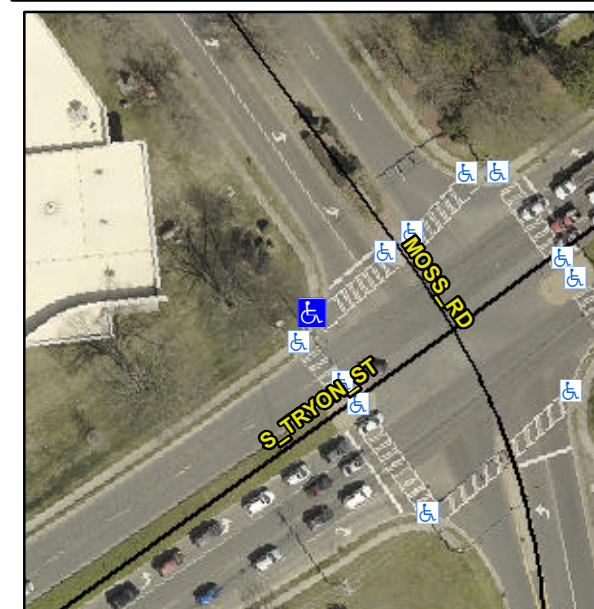
Not Found, R304.5.1, R304.2.2

Compliance	Description	Data	Compliance	Description	Data
N/A	Ramp Length (in)	55.0	No	Ramp Slope (%)	9.0
No	Ramp Width (in)	46.0	Yes	Ramp XSlope (%)	1.6
N/A	Flare Type LT	N/A	N/A	Flare Type RT	N/A
N/A	Flare Slope LT (%)	N/A	N/A	Flare Slope RT (%)	N/A
N/A	Flare Traversable LT?	N/A	N/A	Flare Traversable RT?	N/A
N/A	Landing Length (in)	N/A	N/A	DWS Provided?	N/A
N/A	Landing Width (in)	N/A	N/A	DWS Contrast?	N/A
N/A	Landing Slope (%)	N/A	N/A	DWS Length (in)	N/A
N/A	Landing X Slope (%)	N/A	N/A	DWS Full Width?	N/A
N/A	Landing Curb? (Y/N)	N/A	N/A	DWS Offset (in)	N/A
N/A	Shared Landing?	N/A			
N/A	Gutter Ponding?	N/A	N/A	Gutter Slope (%)	N/A
N/A	Gutter Lip Ht (in)	N/A	N/A	Gutter X Slope (%)	N/A
N/A	Painted X Walk1?	Yes	N/A	Painted X Walk2?	N/A
	X Walk 1 Direction	To NE		X Walk 2 Direction	N/A
N/A	X Walk 1 Width (in)	118.0	N/A	X Walk 2 Width (in)	N/A
	X Walk 1 Slope (%)	1.0		X Walk 2 Slope (%)	N/A
	X Walk 1 X Slope (%)	3.4		X Walk 2 X Slope (%)	N/A

N/A	Ramp inside XWalk1?	Yes	N/A	Ramp inside XWalk2?	N/A
	Road Slope (%)	N/A	N/A	Clear Space?	N/A
	Road X Slope (%)	N/A	N/A	Clear Space to XWalk (in)	N/A
N/A	Any Obstructions?	N/A	N/A	Storm Grate/Utility Hazard?	N/A
	Obstruction Type			Storm Grate/Utility Type	
		N/A			N/A
		Yes		Surface Condition? (G/P)	Good

Possible Solutions:

Remove & Replace Entire Ramp.
