Access Compliance Report

Public Rights-of-Way

(Curb Ramps)

Intersection ID: 46814	Main Street: OLDE_IVY_WY	Cross Street: RED_BIRCH_DR	Location: W
ADA ID: 9DA23B0881D4	Ramp Type: PerpDiag	Initial Pass/Fail: Fail	Overall Compliance: No
		Severity Score: 22.5

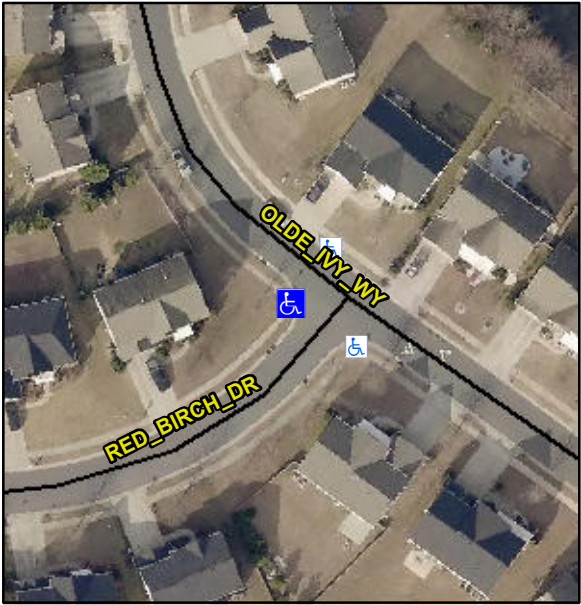
Possible Solutions:		Compliance	Description	Data
	Remove & Replace Curb Ramp With Two New Directional Ramps or Equivalent.		No	Ramp Length (in)	49.0
			No	Ramp Width (in)	37.0
			N/A	Flare Type LT	N/A
			N/A	Flare Slope LT (%)	N/A
			N/A	Flare Traversable LT?	N/A
			N/A	Landing Length (in)	N/A
			N/A	Landing Width (in)	N/A
			N/A	Landing Slope (%)	N/A
			N/A	Landing X Slope (%)	N/A
			N/A	Landing Curb? (Y/N)	N/A
			N/A	Shared Landing?	N/A
			N/A	Gutter Ponding?	N/A
			N/A	Gutter Lip Ht (in)	N/A
			No	Painted X Walk1?	N/A
				X Walk 1 Direction	To SE
			N/A	X Walk 1 Width (in)	N/A
				X Walk 1 Slope (%)	2.4
				X Walk 1 X Slope (%)	0.7
			N/A	Ramp inside XWalk1?	N/A
<p>Surveyor Notes:</p> <p>N/A</p> <p>PROW/ADA:</p> <p>R304.5.1, R304.2.2, R304.5.3</p>			N/A	Flare Type RT	N/A
			N/A	Flare Slope RT (%)	N/A
			N/A	Flare Traversable RT?	N/A

N/A	DWS Provided?	N/A
			N/A	DWS Contrast?	N/A
			N/A	DWS Length (in)	N/A
			N/A	DWS Full Width?	N/A
			N/A	DWS Offset (in)	N/A
			N/A	Gutter Slope (%)	N/A
			N/A	Gutter X Slope (%)	N/A
			N/A	Painted X Walk2?	No
				X Walk 2 Direction	To NE
			N/A	X Walk 2 Width (in)	N/A
				X Walk 2 Slope (%)	0.2
				X Walk 2 X Slope (%)	2.4
			N/A	Ramp inside XWalk2?	N/A
			N/A	Clear Space?	N/A
			N/A	Clear Space to XWalk (in)	N/A
			N/A	Storm Grate/Utility Hazard?	N/A
				Storm Grate/Utility Type	
			N/A		N/A
			Yes	Surface Condition? (G/P)	Good
Total Cost:		\$ 3200.00
