# Access Compliance Report

## Public Rights-of-Way

### (Curb Ramps)

Intersection ID: 10019134	Main Street: STROUD_PARK_CT	Cross Street: N/A	Location: S
ADA ID: 9DC2299CE167	Ramp Type: Perp	Initial Pass/Fail: Fail	Overall Compliance: No
		Severity Score: 10

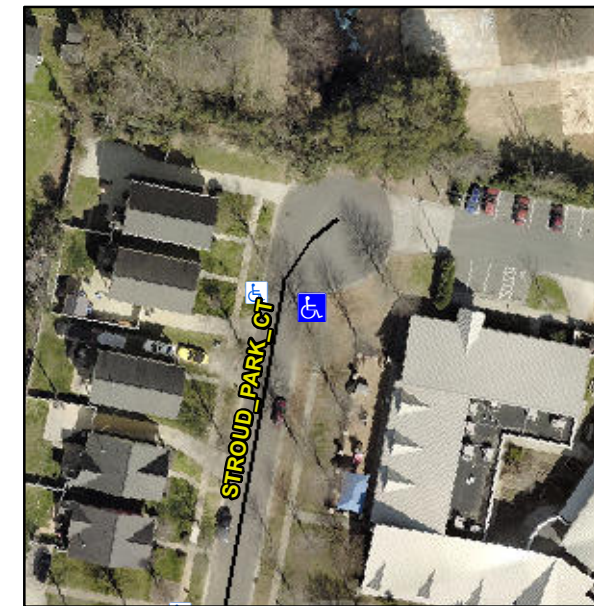
**Not Found, R304.5.1, R304.5.3**

Compliance	Description	Data	Compliance	Description	Data
N/A	Ramp Length (in)	44.0	Yes	Ramp Slope (%)	6.2
No	Ramp Width (in)	47.5	No	Ramp XSlope (%)	4.2
N/A	Flare Type LT	N/A	N/A	Flare Type RT	N/A
N/A	Flare Slope LT (%)	N/A	N/A	Flare Slope RT (%)	N/A
N/A	Flare Traversable LT?	N/A	N/A	Flare Traversable RT?	N/A
N/A	Landing Length (in)	N/A	N/A	DWS Provided?	N/A
N/A	Landing Width (in)	N/A	N/A	DWS Contrast?	N/A
N/A	Landing Slope (%)	N/A	N/A	DWS Length (in)	N/A
N/A	Landing X Slope (%)	N/A	N/A	DWS Full Width?	N/A
N/A	Landing Curb? (Y/N)	N/A	N/A	DWS Offset (in)	N/A
N/A	Shared Landing?	N/A			
N/A	Gutter Ponding?	N/A	N/A	Gutter Slope (%)	N/A
N/A	Gutter Lip Ht (in)	0.5	N/A	Gutter X Slope (%)	N/A
N/A	Painted X Walk1?	No	N/A	Painted X Walk2?	N/A
	X Walk 1 Direction	To SW		X Walk 2 Direction	N/A
N/A	X Walk 1 Width (in)	N/A	N/A	X Walk 2 Width (in)	N/A
	X Walk 1 Slope (%)	0.4		X Walk 2 Slope (%)	N/A
	X Walk 1 X Slope (%)	3.6		X Walk 2 X Slope (%)	N/A

N/A	Ramp inside XWalk1?	N/A	N/A	Ramp inside XWalk2?	N/A
	Road Slope (%)	N/A	N/A	Clear Space?	N/A
	Road X Slope (%)	N/A	N/A	Clear Space to XWalk (in)	N/A
N/A	Any Obstructions?	N/A	N/A	Storm Grate/Utility Hazard?	N/A
	Obstruction Type			Storm Grate/Utility Type	
		N/A			N/A
			Yes	Surface Condition? (G/P)	Good

**Remove & Replace Entire Ramp.**

Total Cost: \$ 1850.00
