# Access Compliance Report

## Public Rights-of-Way

### (Curb Ramps)

| Intersection ID: 23196 | Main Street: IVEY_CREEK_DR | Cross Street: ERWIN_RD | Location: NE |

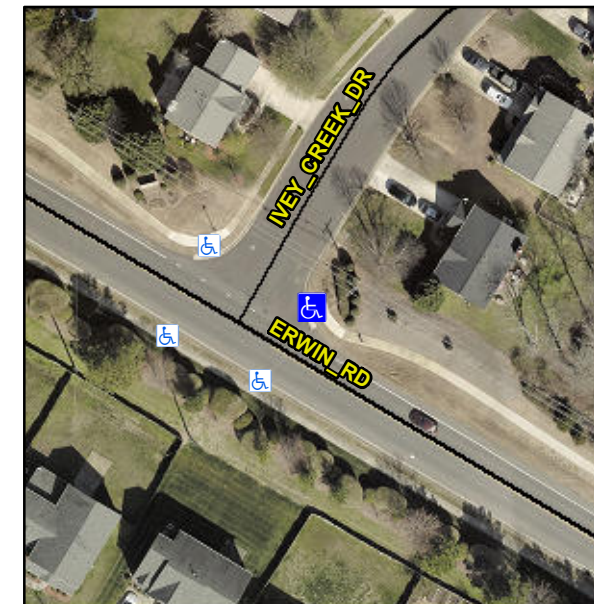
| ADA ID: 9DC3CE7635B7 | Ramp Type: Combination2 | Initial Pass/Fail: Fail | Overall Compliance: No |
| Severity Score: 12.5 | | | |

**Not Found, R304.5.3**

| Compliance | Description | Data | Compliance | Description | Data |
|---|---|---|---|---|---|
| Yes | Ramp Width (in) | 60.0 | No | Ramp XSlope (%) | 5.8 |

**Remove & Replace Entire Ramp.**

Total Cost: \$ 1600.00

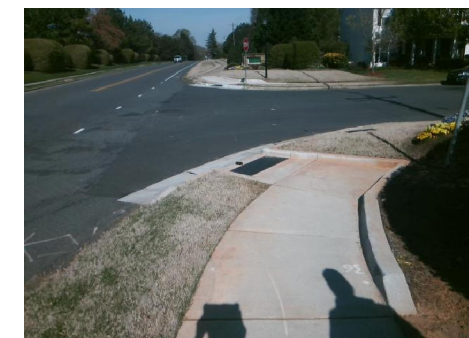
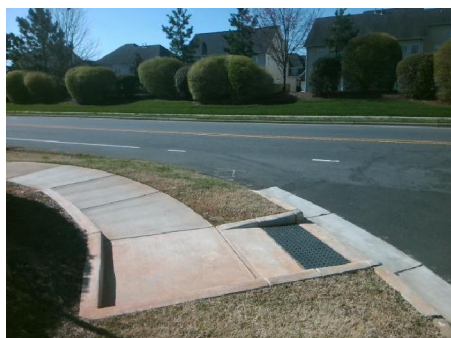
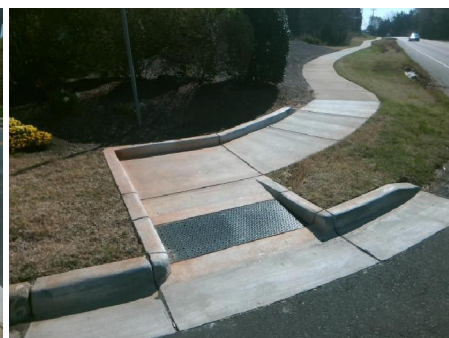
| Compliance | Description | Data | Compliance | Description | Data |
|---|---|---|---|---|---|
| | | | Yes | Surface Condition? (G/P) | Good |
