# Access Compliance Report

## Public Rights-of-Way

### (Curb Ramps)

| Intersection ID: 50636 | Main Street: BLUE_GROVE_RD | Cross Street: RED_WATER_RD | Location: SW |

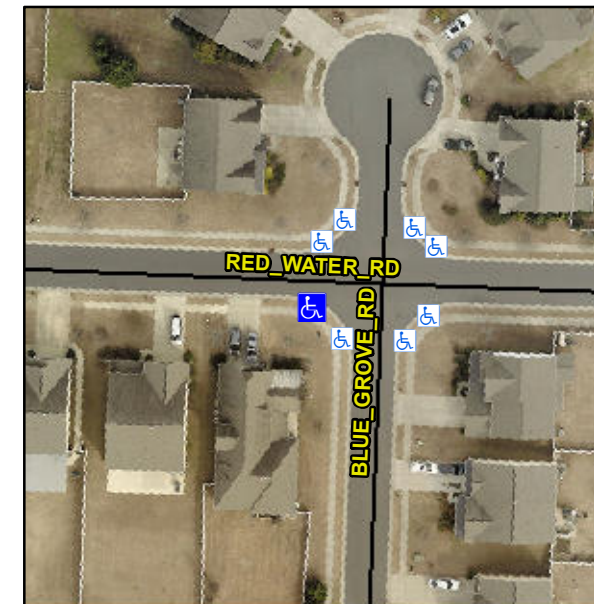
| ADA ID: 9DD059930DC5 | Ramp Type: Perp | Initial Pass/Fail: Pass | Overall Compliance: No |

**Not Found, R304.2.2-Perp, R304.3.2-Para**

| Compliance | Description | Data | Compliance | Description | Data |
|---|---|---|---|---|---|
| No | Landing Slope (%) | 2.7 | Yes | DWS Length (in) | 24.5 |

**Remove & Replace Entire Ramp.**

Total Cost: \$ 1850.00
