Access Compliance Report

Public Rights-of-Way

(Curb Ramps)

Intersection ID: 25272	Main Street: BRIDLE_BROOK_WY	Cross Street: MAYNARD_RD	Location: W
ADA ID: 9DD322B450F7	Ramp Type: Perp	Initial Pass/Fail: Fail	Overall Compliance: No
Severity Score: 37.5			
Codes/Mitigation Info/Possible Solution		Field Measurements/Component Compliance

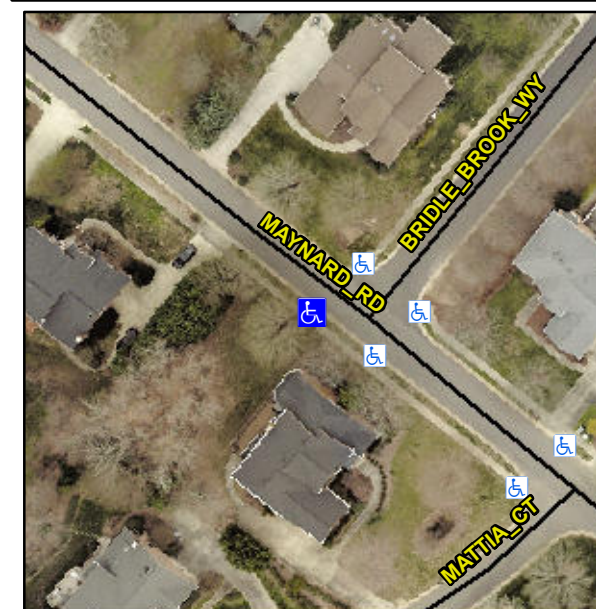
Not Found, R304.2.2, R304.5.3

Compliance	Description	Data	Compliance	Description	Data
N/A	Ramp Length (in)	51.0	No	Ramp Slope (%)	13.6
Yes	Ramp Width (in)	49.0	No	Ramp XSlope (%)	6.5
N/A	Flare Type LT	N/A	N/A	Flare Type RT	N/A
N/A	Flare Slope LT (%)	N/A	N/A	Flare Slope RT (%)	N/A
N/A	Flare Traversable LT?	N/A	N/A	Flare Traversable RT?	N/A
N/A	Landing Length (in)	N/A	N/A	DWS Provided?	N/A
N/A	Landing Width (in)	N/A	N/A	DWS Contrast?	N/A
N/A	Landing Slope (%)	N/A	N/A	DWS Length (in)	N/A
N/A	Landing X Slope (%)	N/A	N/A	DWS Full Width?	N/A
N/A	Landing Curb? (Y/N)	N/A	N/A	DWS Offset (in)	N/A
N/A	Shared Landing?	N/A			
N/A	Gutter Ponding?	N/A	N/A	Gutter Slope (%)	N/A
N/A	Gutter Lip Ht (in)	N/A	N/A	Gutter X Slope (%)	N/A
N/A	Painted X Walk1?	No	N/A	Painted X Walk2?	N/A
	X Walk 1 Direction	To NE		X Walk 2 Direction	N/A
N/A	X Walk 1 Width (in)	N/A	N/A	X Walk 2 Width (in)	N/A
	X Walk 1 Slope (%)	0.6		X Walk 2 Slope (%)	N/A
	X Walk 1 X Slope (%)	6.9		X Walk 2 X Slope (%)	N/A

N/A	Ramp inside XWalk1?	N/A	N/A	Ramp inside XWalk2?	N/A
	Road Slope (%)	N/A	N/A	Clear Space?	N/A
	Road X Slope (%)	N/A	N/A	Clear Space to XWalk (in)	N/A
N/A	Any Obstructions?	N/A	N/A	Storm Grate/Utility Hazard?	N/A
	Obstruction Type			Storm Grate/Utility Type	
		N/A			N/A
			Yes	Surface Condition? (G/P)	Good

Possible Solutions:

Remove & Replace Entire Ramp.
