# Access Compliance Report

## Public Rights-of-Way (Curb Ramps)

Intersection ID: 10011236	Main Street: N_CHURCH_ST	Cross Street: WADSWORTH_PL	Location: SW
ADA ID: 9DD98EC301B4	Ramp Type: Directional1	Initial Pass/Fail: Pass	Overall Compliance: No
Severity Score: 0			
Codes/Mitigation Info/Possible Solution		Field Measurements/Component Compliance

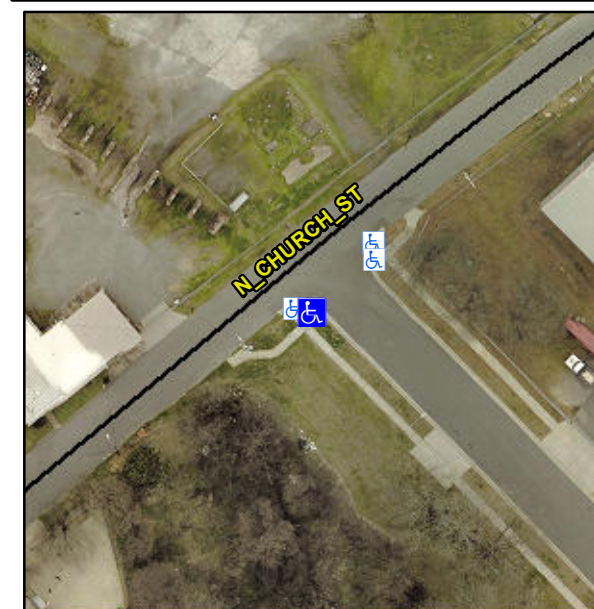
Compliance	Description	Data	Compliance	Description	Data
N/A	Ramp Length (in)	76.0	Yes	Grade Break?	Yes
Yes	Ramp Width (in)	57.0	No	Grade Break Slope (%)	9.4
Yes	Ramp Slope (%)	7.0	Yes	Grade Break XSlope (%)	1.3
Yes	Ramp XSlope (%)	0.7			
Yes	Flare Type LT	N/A	Yes	Flare Type RT	N/A
N/A	Flare Slope LT (%)	N/A	N/A	Flare Slope RT (%)	N/A
N/A	Flare Traversable LT?	No	N/A	Flare Traversable RT?	No
Yes	Landing Length (in)	59.5	Yes	DWS Provided?	Yes
Yes	Landing Width (in)	69.5	Yes	DWS Contrast?	Yes
Yes	Landing Slope (%)	0.4	Yes	DWS Length (in)	24.0
No	Landing X Slope (%)	2.2	Yes	DWS Full Width?	Yes
N/A	Landing Curb? (Y/N)	N/A	Yes	DWS Offset LT (in)	19.5
N/A	Shared Landing?	Yes	No	DWS Offset RT (in)	6.5
Yes	Gutter Ponding?	No	Yes	Gutter Slope (%)	4.5
Yes	Gutter Lip Ht (in)	0.0	No	Gutter X Slope (%)	3.7
N/A	Painted X Walk1?	No		Road Slope (%)	0.9
	X Walk 1 Direction	To NE		Road X Slope (%)	3.5
	X Walk 1 Width (in)	N/A		Clear Space?	Yes

X Walk 1 Slope (%)	0.9	N/A	Clear Space to XWalk (in)	N/A
	X Walk 1 X Slope (%)	3.5	Yes	Storm Grate/Utility Hazard?	No
N/A	Ramp inside XWalk1?	N/A		Storm Grate/Utility Type	
Yes	Any Obstructions?	No			N/A
	Obstruction Type		Yes	Surface Condition? (G/P)	Good
			N/A	Curb Slope (%)	6.8

Possible Solutions:

**Remove & Replace Entire Ramp.  
Remove & Replace Gutter.**
