## Access Compliance Report Public Rights-of-Way (Curb Ramps)

Intersection ID: 29422 Main Street: BRADSTREET\_COMMONS\_WYCross Street: SHINY\_MEADOW\_LN Location: SE

ADA ID: 9DDDA1F50D74 Ramp Type: Perp Initial Pass/Fail: Fail Overall Compliance: No Severity Score: 21.25

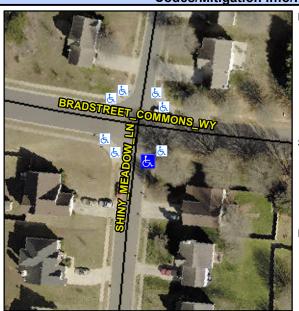
Field Measurements/Component Compliance						
Comp	liance Description	Data	Comp	liance Description	Data	
N/A	Ramp Length (in)	48.0	Yes	Ramp Slope (%)	7.8	
No	Ramp Width (in)	47.5	No	Ramp XSlope (%)	5.5	
N/A	Flare Type LT	N/A	N/A	Flare Type RT	N/A	
N/A	Flare Slope LT (%)	N/A	N/A	Flare Slope RT (%)	N/A	
N/A	Flare Traversable LT?	N/A	N/A	Flare Traversable RT?	N/A	
N/A	Landing Length (in)	N/A	N/A	DWS Provided?	N/A	
N/A	Landing Width (in)	N/A	N/A	DWS Contrast?	N/A	
N/A	Landing Slope (%)	N/A	N/A	DWS Length (in)	N/A	
N/A	Landing X Slope (%)	N/A	N/A	DWS Full Width?	N/A	
N/A	Landing Curb? (Y/N)	N/A	N/A	DWS Offset (in)	N/A	
N/A	Shared Landing?	N/A				
N/A	Gutter Ponding?	N/A	N/A	Gutter Slope (%)	N/A	
N/A	Gutter Lip Ht (in)	N/A	N/A	Gutter X Slope (%)	N/A	
N/A	Painted X Walk1?	No	N/A	Painted X Walk2?	N/A	
	X Walk 1 Direction	To W		X Walk 2 Direction	N/A	
N/A	X Walk 1 Width (in)	N/A	N/A	X Walk 2 Width (in)	N/A	
	X Walk 1 Slope (%)	6.5		X Walk 2 Slope (%)	N/A

X Walk 1 X Slope (%)	1.7		X Walk 2 X Slope (%)	N/A	
N/A	Ramp inside XWalk1?	N/A	N/A	Ramp inside XWalk2?	N/A	
	Road Slope (%)	N/A	N/A	Clear Space?	N/A	
	Road X Slope (%)	N/A	N/A	Clear Space to XWalk (in)	N/A	
N/A	Any Obstructions?	N/A	N/A	Storm Grate/Utility Hazard?	N/A	
	Obstruction Type			Storm Grate/Utility Type		
		N/A			N/A	
			Yes	Surface Condition? (G/P)	Good

russible solution	
Possible Solutions:	Com
Remove & Replace Entire Ramp.	N/A
·	No
	N/A
	N/A
	N/A
	N/A
Surveyor Notes:	N/A
N/A	N/A
	N/A
	N/A
	N/A
PROW/ADA:	N/A
R304.5.1, R304.5.3	N/A
,	N/A
	N/A
	N/A
