# Access Compliance Report

## Public Rights-of-Way

| Intersection ID: 53704 | Main Street: MILLSTREAM RIDGE DR | Cross Street: CHRISTENBURY RD | Location: S |
| ADA ID: 9DE9DEB44D21 | Ramp Type: BlendTrans1 | Initial Pass/Fail: Pass | Overall Compliance: No |

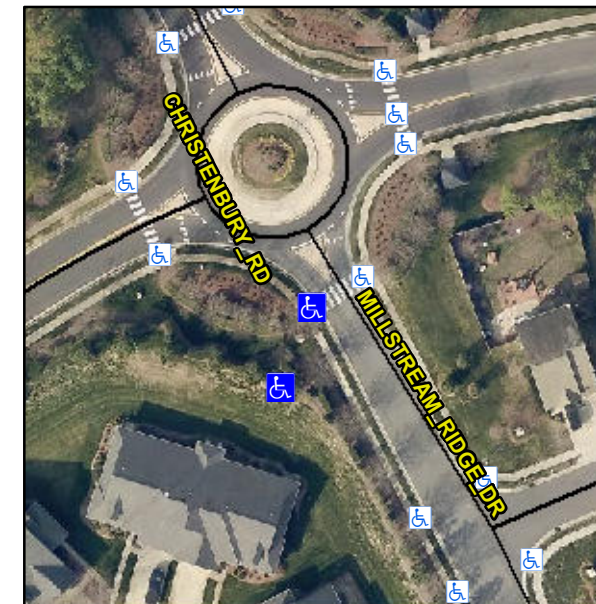
**LNDG LIP 1.0**

**Not Found, R304.2.1, R304.2.2-Perp, R304.3.2-Para, R302.7.2, R304.5.4**

| Compliance | Description | Data | Compliance | Description | Data |
|---|---|---|---|---|---|
| No | Landing Length (in) | 47.0 | Yes | DWS Provided? | Yes |
| No | Landing Slope (%) | 4.0 | Yes | DWS Length (in) | 24.0 |
| Yes | Gutter Ponding? | No | No | Gutter Slope (%) | 5.1 |
| No | Gutter Lip Ht (in) | 1.0 | Yes | Gutter X Slope (%) | 0.0 |

**Remove & Replace Curb Ramp With Two New Directional Ramps or Equivalent. Remove & Replace Gutter.**
