Access Compliance Report

Public Rights-of-Way

(Curb Ramps)

Intersection ID: 12388	Main Street: BERRYHILL_RD	Cross Street: GREENLAND_AV	Location: NW
ADA ID: 9DF4EDC199BE	Ramp Type: Perp	Initial Pass/Fail: Fail	Overall Compliance: No
Severity Score: 33.75			
Codes/Mitigation Info/Possible Solution		Field Measurements/Component Compliance

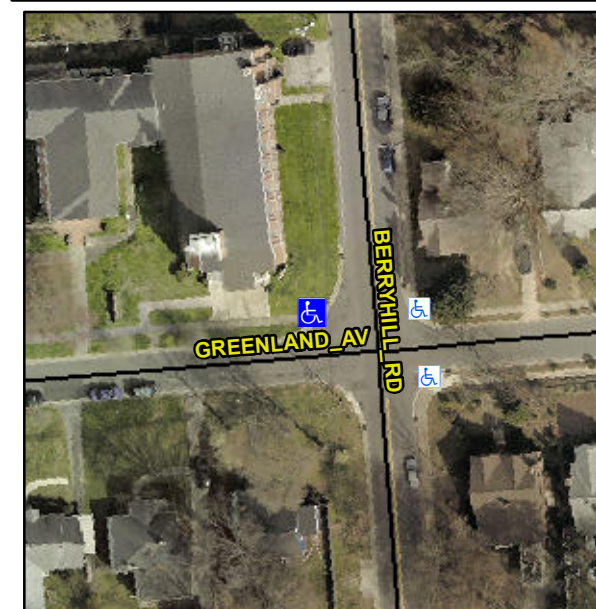
Not Found, R304.5.1, R304.2.2, R304.5.3

Compliance	Description	Data	Compliance	Description	Data
N/A	Ramp Length (in)	39.0	No	Ramp Slope (%)	11.7
No	Ramp Width (in)	40.0	No	Ramp XSlope (%)	5.7
N/A	Flare Type LT	N/A	N/A	Flare Type RT	N/A
N/A	Flare Slope LT (%)	N/A	N/A	Flare Slope RT (%)	N/A
N/A	Flare Traversable LT?	N/A	N/A	Flare Traversable RT?	N/A
N/A	Landing Length (in)	N/A	N/A	DWS Provided?	N/A
N/A	Landing Width (in)	N/A	N/A	DWS Contrast?	N/A
N/A	Landing Slope (%)	N/A	N/A	DWS Length (in)	N/A
N/A	Landing X Slope (%)	N/A	N/A	DWS Full Width?	N/A
N/A	Landing Curb? (Y/N)	N/A	N/A	DWS Offset (in)	N/A
N/A	Shared Landing?	N/A			
N/A	Gutter Ponding?	N/A	N/A	Gutter Slope (%)	N/A
N/A	Gutter Lip Ht (in)	N/A	N/A	Gutter X Slope (%)	N/A
N/A	Painted X Walk1?	No	N/A	Painted X Walk2?	N/A
	X Walk 1 Direction	To E		X Walk 2 Direction	N/A
N/A	X Walk 1 Width (in)	N/A	N/A	X Walk 2 Width (in)	N/A
	X Walk 1 Slope (%)	1.4		X Walk 2 Slope (%)	N/A
	X Walk 1 X Slope (%)	4.7		X Walk 2 X Slope (%)	N/A

Remove & Replace Entire Ramp.
