Access Compliance Report

Public Rights-of-Way

(Curb Ramps)

Intersection ID: 13715	Main Street: E_MOREHEAD_ST	Cross Street: MYRTLE_AV	Location: S
ADA ID: 9DF7F0D8296E	Ramp Type: Perp	Initial Pass/Fail: Fail	Overall Compliance: No
			Severity Score: 1.25

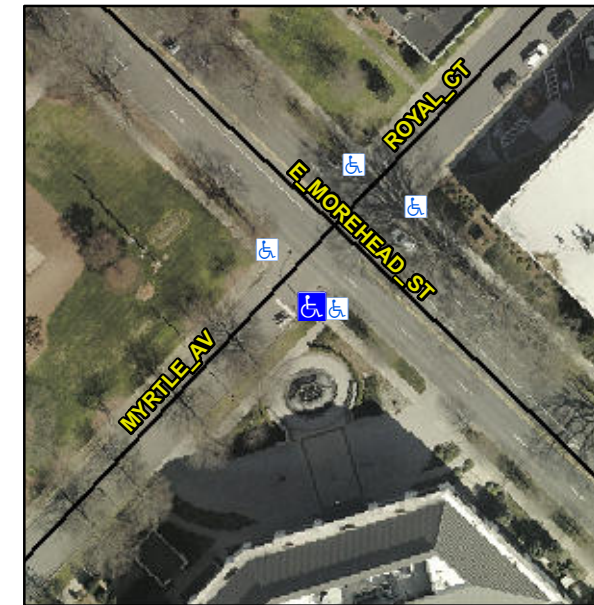
Not Found, R304.5.3

Compliance	Description	Data	Compliance	Description	Data
N/A	Ramp Length (in)	101.0	Yes	Ramp Slope (%)	5.7
Yes	Ramp Width (in)	69.0	No	Ramp XSlope (%)	2.8
N/A	Flare Type LT	N/A	N/A	Flare Type RT	N/A
N/A	Flare Slope LT (%)	N/A	N/A	Flare Slope RT (%)	N/A
N/A	Flare Traversable LT?	N/A	N/A	Flare Traversable RT?	N/A
N/A	Landing Length (in)	N/A	N/A	DWS Provided?	N/A
N/A	Landing Width (in)	N/A	N/A	DWS Contrast?	N/A
N/A	Landing Slope (%)	N/A	N/A	DWS Length (in)	N/A
N/A	Landing X Slope (%)	N/A	N/A	DWS Full Width?	N/A
N/A	Landing Curb? (Y/N)	N/A	N/A	DWS Offset (in)	N/A
N/A	Shared Landing?	N/A			
N/A	Gutter Ponding?	N/A	N/A	Gutter Slope (%)	N/A
N/A	Gutter Lip Ht (in)	N/A	N/A	Gutter X Slope (%)	N/A
N/A	Painted X Walk1?	No	N/A	Painted X Walk2?	N/A
	X Walk 1 Direction	To NW		X Walk 2 Direction	N/A
N/A	X Walk 1 Width (in)	N/A	N/A	X Walk 2 Width (in)	N/A
	X Walk 1 Slope (%)	5.5		X Walk 2 Slope (%)	N/A
	X Walk 1 X Slope (%)	2.0		X Walk 2 X Slope (%)	N/A

N/A	Ramp inside XWalk1?	N/A	N/A	Ramp inside XWalk2?	N/A
	Road Slope (%)	N/A	N/A	Clear Space?	N/A
	Road X Slope (%)	N/A	N/A	Clear Space to XWalk (in)	N/A
N/A	Any Obstructions?	N/A	N/A	Storm Grate/Utility Hazard?	N/A
	Obstruction Type			Storm Grate/Utility Type	
		N/A			N/A
			Yes	Surface Condition? (G/P)	Good

Possible Solutions:

Remove & Replace Entire Ramp.

Total Cost: \$ 1850.00
