Access Compliance Report

Public Rights-of-Way

(Curb Ramps)

Intersection ID: 46749	Main Street: NORMANS_LANDING_DR	Cross Street: HAVASU_ST	Location: SW
ADA ID: 9E028F8F790F	Ramp Type: PerpDiag	Initial Pass/Fail: Fail	Overall Compliance: No
Severity Score: 22.5			
Codes/Mitigation Info/Possible Solution		Field Measurements/Component Compliance

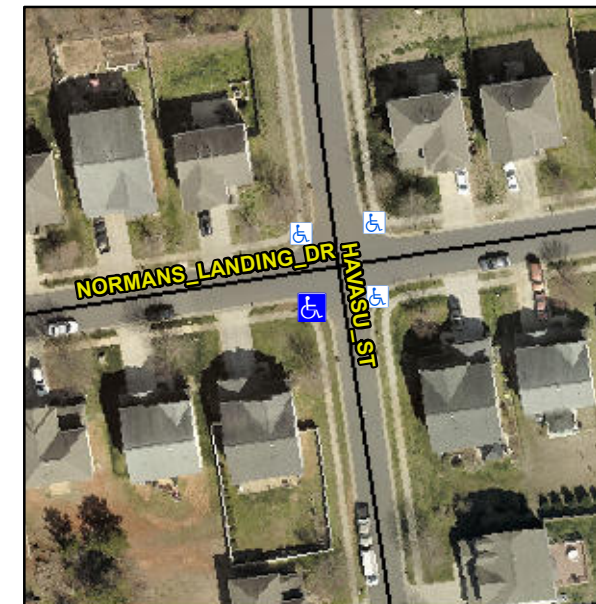
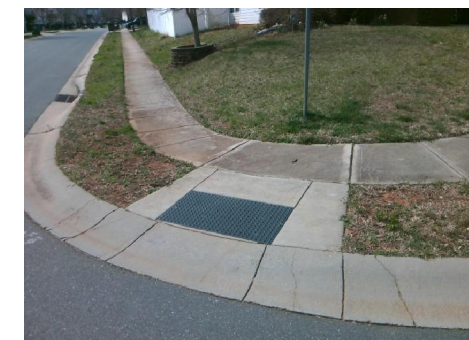
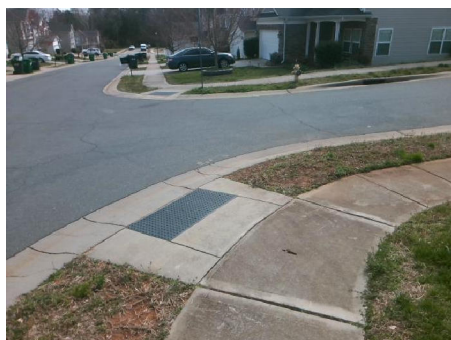
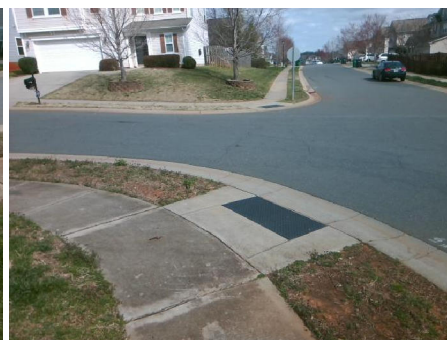
Not Found, R304.5.1, R304.2.2, R304.5.3

Compliance	Description	Data	Compliance	Description	Data
N/A	Ramp Length (in)	48.0	No	Ramp Slope (%)	8.8
No	Ramp Width (in)	45.5	No	Ramp XSlope (%)	3.5
N/A	Flare Type LT	N/A	N/A	Flare Type RT	N/A
N/A	Flare Slope LT (%)	N/A	N/A	Flare Slope RT (%)	N/A
N/A	Flare Traversable LT?	N/A	N/A	Flare Traversable RT?	N/A
N/A	Landing Length (in)	N/A	N/A	DWS Provided?	N/A
N/A	Landing Width (in)	N/A	N/A	DWS Contrast?	N/A
N/A	Landing Slope (%)	N/A	N/A	DWS Length (in)	N/A
N/A	Landing X Slope (%)	N/A	N/A	DWS Full Width?	N/A
N/A	Landing Curb? (Y/N)	N/A	N/A	DWS Offset (in)	N/A
N/A	Shared Landing?	N/A			
N/A	Gutter Ponding?	N/A	N/A	Gutter Slope (%)	N/A
N/A	Gutter Lip Ht (in)	N/A	N/A	Gutter X Slope (%)	N/A
N/A	Painted X Walk1?	No	N/A	Painted X Walk2?	No
	X Walk 1 Direction	To E		X Walk 2 Direction	To N
N/A	X Walk 1 Width (in)	N/A	N/A	X Walk 2 Width (in)	N/A
	X Walk 1 Slope (%)	3.0		X Walk 2 Slope (%)	2.5
	X Walk 1 X Slope (%)	1.2		X Walk 2 X Slope (%)	5.4

N/A	Ramp inside XWalk1?	N/A	N/A	Ramp inside XWalk2?	N/A
	Road Slope (%)	3.8	N/A	Clear Space?	N/A
	Road X Slope (%)	2.5	N/A	Clear Space to XWalk (in)	N/A
N/A	Any Obstructions?	N/A	N/A	Storm Grate/Utility Hazard?	N/A
	Obstruction Type			Storm Grate/Utility Type	
		N/A			N/A
		Yes		Surface Condition? (G/P)	Good

Remove & Replace Curb Ramp With Two New Directional Ramps or Equivalent.
