Access Compliance Report

Public Rights-of-Way

(Curb Ramps)

Intersection ID: 8348	Main Street: LASALLE_ST	Cross Street: TAYLOR_AV	Location: SW
ADA ID: 9E0A2B69E68A	Ramp Type: Perp	Initial Pass/Fail: Fail	Overall Compliance: No
Severity Score: 12.5			
Codes/Mitigation Info/Possible Solution		Field Measurements/Component Compliance

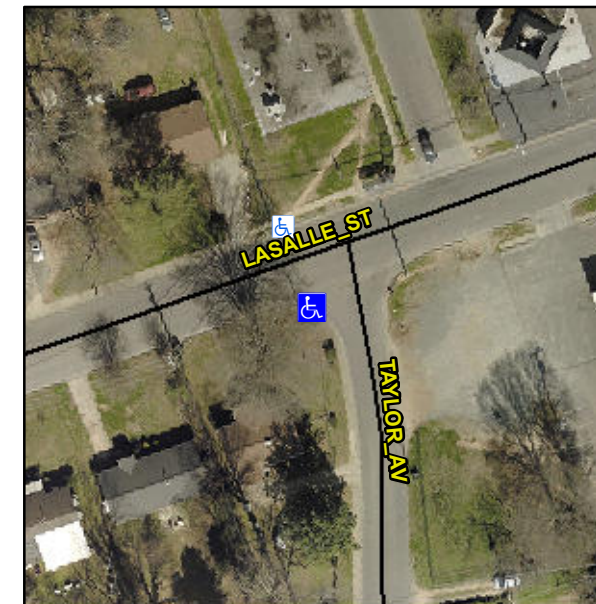
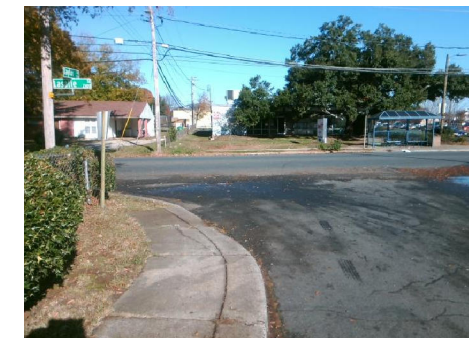
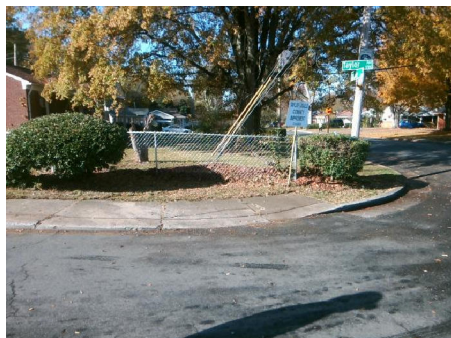
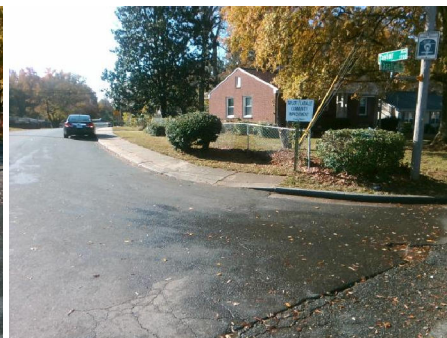
Not Found, R304.2.2

Compliance	Description	Data	Compliance	Description	Data
N/A	Ramp Length (in)	37.0	No	Ramp Slope (%)	11.9
Yes	Ramp Width (in)	72.0	Yes	Ramp XSlope (%)	1.1
N/A	Flare Type LT	N/A	N/A	Flare Type RT	N/A
N/A	Flare Slope LT (%)	N/A	N/A	Flare Slope RT (%)	N/A
N/A	Flare Traversable LT?	N/A	N/A	Flare Traversable RT?	N/A
N/A	Landing Length (in)	N/A	N/A	DWS Provided?	N/A
N/A	Landing Width (in)	N/A	N/A	DWS Contrast?	N/A
N/A	Landing Slope (%)	N/A	N/A	DWS Length (in)	N/A
N/A	Landing X Slope (%)	N/A	N/A	DWS Full Width?	N/A
N/A	Landing Curb? (Y/N)	N/A	N/A	DWS Offset (in)	N/A
N/A	Shared Landing?	N/A			
N/A	Gutter Ponding?	N/A	N/A	Gutter Slope (%)	N/A
N/A	Gutter Lip Ht (in)	N/A	N/A	Gutter X Slope (%)	N/A
N/A	Painted X Walk1?	No	N/A	Painted X Walk2?	N/A
	X Walk 1 Direction	To N		X Walk 2 Direction	N/A
N/A	X Walk 1 Width (in)	N/A	N/A	X Walk 2 Width (in)	N/A
	X Walk 1 Slope (%)	2.8		X Walk 2 Slope (%)	N/A
	X Walk 1 X Slope (%)	2.6		X Walk 2 X Slope (%)	N/A

N/A	Ramp inside XWalk1?	N/A	N/A	Ramp inside XWalk2?	N/A
	Road Slope (%)	N/A	N/A	Clear Space?	N/A
	Road X Slope (%)	N/A	N/A	Clear Space to XWalk (in)	N/A
N/A	Any Obstructions?	N/A	N/A	Storm Grate/Utility Hazard?	N/A
	Obstruction Type			Storm Grate/Utility Type	
		N/A			N/A
			Yes	Surface Condition? (G/P)	Good

Possible Solutions:

Remove & Replace Entire Ramp.

Total Cost: \$ 1850.00
