# Access Compliance Report

## Public Rights-of-Way

| Intersection ID: 51538 | Main Street: GLENBURN_LN | Cross Street: KINGAUSSIE | Location: NW |
| ADA ID: 9E0A4A491153 | Ramp Type: BlendTrans1 | Initial Pass/Fail: Fail | Overall Compliance: No |

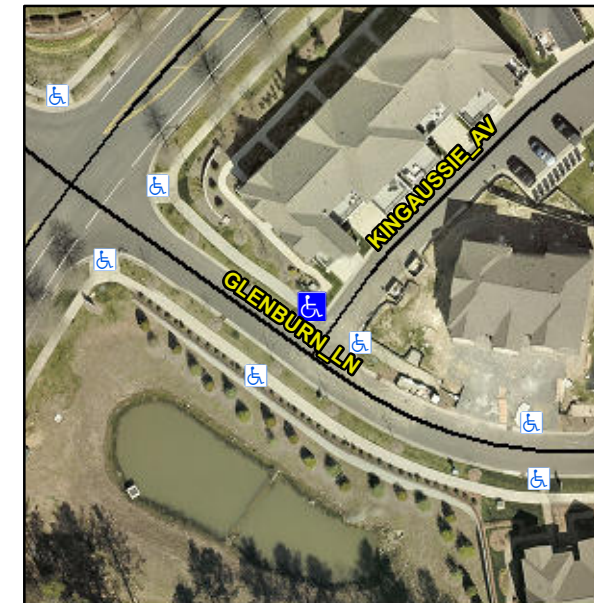
| | | | Severity Score: 21.25 |

**Not Found, R304.5.1, R304.5.3**

| Compliance | Description | Data | Compliance | Description | Data |
|---|---|---|---|---|---|
| No | Ramp Width (in) | 47.5 | No | BlendTrans XSlope (%) | 6.2 |
| | | | No | Curb Slope (%) | 11.2 |

**Remove & Replace Curb Ramp With Two New Directional Ramps or Equivalent.**

Total Cost: \$ 3200.00
