Access Compliance Report

Public Rights-of-Way (Curb Ramps)

Intersection ID: 49252	Main Street: ROCKLAND_DR	Cross Street: BROOKE_NICOLE_PL	Location:	N
ADA ID: 9E0AF80981AB	Ramp Type: Perp	Initial Pass/Fail: Fail	Overall Compliance: No	Severity Score: 46.25
Codes/Mitigation Info/Possible Solution		Field Measurements/Component Compliance

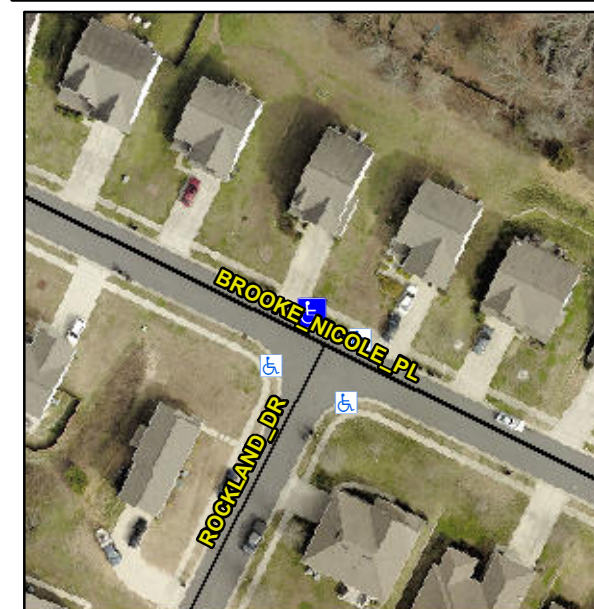
Not Found, R304.5.1, R304.2.2, R304.5.3

Compliance	Description	Data	Compliance	Description	Data
N/A	Ramp Length (in)	48.0	No	Ramp Slope (%)	9.4
No	Ramp Width (in)	47.0	No	Ramp XSlope (%)	9.6
N/A	Flare Type LT	N/A	N/A	Flare Type RT	N/A
N/A	Flare Slope LT (%)	N/A	N/A	Flare Slope RT (%)	N/A
N/A	Flare Traversable LT?	N/A	N/A	Flare Traversable RT?	N/A
N/A	Landing Length (in)	N/A	N/A	DWS Provided?	N/A
N/A	Landing Width (in)	N/A	N/A	DWS Contrast?	N/A
N/A	Landing Slope (%)	N/A	N/A	DWS Length (in)	N/A
N/A	Landing X Slope (%)	N/A	N/A	DWS Full Width?	N/A
N/A	Landing Curb? (Y/N)	N/A	N/A	DWS Offset (in)	N/A
N/A	Shared Landing?	N/A			
N/A	Gutter Ponding?	N/A	N/A	Gutter Slope (%)	N/A
N/A	Gutter Lip Ht (in)	N/A	N/A	Gutter X Slope (%)	N/A
N/A	Painted X Walk1?	No	N/A	Painted X Walk2?	N/A
	X Walk 1 Direction	To W		X Walk 2 Direction	N/A
N/A	X Walk 1 Width (in)	N/A	N/A	X Walk 2 Width (in)	N/A
	X Walk 1 Slope (%)	3.2		X Walk 2 Slope (%)	N/A
	X Walk 1 X Slope (%)	8.5		X Walk 2 X Slope (%)	N/A

N/A	Ramp inside XWalk1?	N/A	N/A	Ramp inside XWalk2?	N/A
	Road Slope (%)	N/A	N/A	Clear Space?	N/A
	Road X Slope (%)	N/A	N/A	Clear Space to XWalk (in)	N/A
N/A	Any Obstructions?	N/A	N/A	Storm Grate/Utility Hazard?	N/A
	Obstruction Type			Storm Grate/Utility Type	
		N/A			N/A
			Yes	Surface Condition? (G/P)	Good

Possible Solutions:

Remove & Replace Entire Ramp.
