Access Compliance Report

Public Rights-of-Way

(Curb Ramps)

Intersection ID: 50747	Main Street: MONTELENA_DR	Cross Street: ARTESA_CT	Location:	E
ADA ID: 9E0E2081EBDB	Ramp Type: Perp	Initial Pass/Fail: Fail	Overall Compliance: No	Severity Score: 10
Codes/Mitigation Info/Possible Solution		Field Measurements/Component Compliance

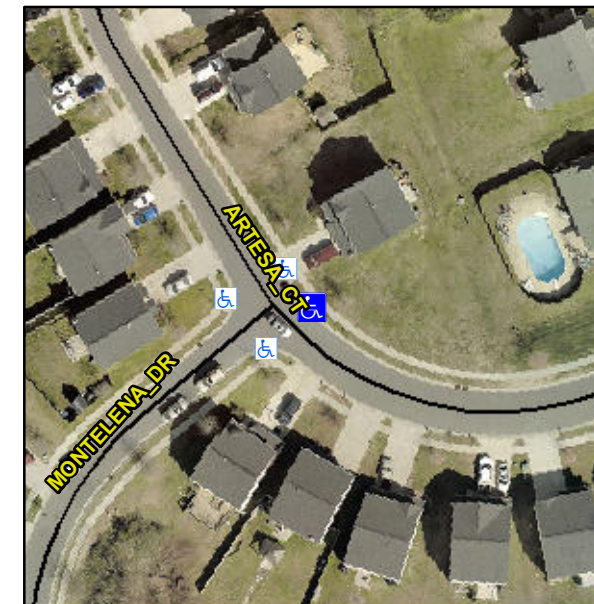
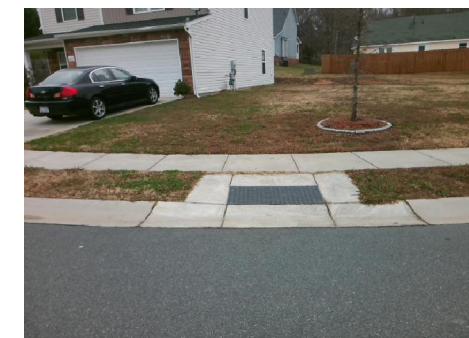
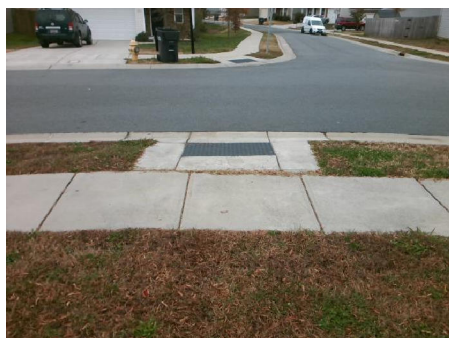
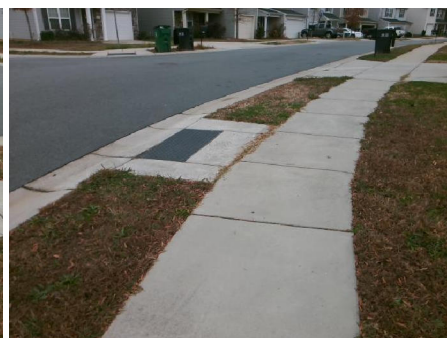
Not Found, R304.5.1, R304.5.3

Compliance	Description	Data	Compliance	Description	Data
N/A	Ramp Length (in)	48.0	Yes	Ramp Slope (%)	8.0
No	Ramp Width (in)	47.5	No	Ramp XSlope (%)	3.8
N/A	Flare Type LT	N/A	N/A	Flare Type RT	N/A
N/A	Flare Slope LT (%)	N/A	N/A	Flare Slope RT (%)	N/A
N/A	Flare Traversable LT?	N/A	N/A	Flare Traversable RT?	N/A
N/A	Landing Length (in)	N/A	N/A	DWS Provided?	N/A
N/A	Landing Width (in)	N/A	N/A	DWS Contrast?	N/A
N/A	Landing Slope (%)	N/A	N/A	DWS Length (in)	N/A
N/A	Landing X Slope (%)	N/A	N/A	DWS Full Width?	N/A
N/A	Landing Curb? (Y/N)	N/A	N/A	DWS Offset (in)	N/A
N/A	Shared Landing?	N/A			
N/A	Gutter Ponding?	N/A	N/A	Gutter Slope (%)	N/A
N/A	Gutter Lip Ht (in)	N/A	N/A	Gutter X Slope (%)	N/A
N/A	Painted X Walk1?	No	N/A	Painted X Walk2?	N/A
	X Walk 1 Direction	To SW		X Walk 2 Direction	N/A
N/A	X Walk 1 Width (in)	N/A	N/A	X Walk 2 Width (in)	N/A
	X Walk 1 Slope (%)	4.0		X Walk 2 Slope (%)	N/A
	X Walk 1 X Slope (%)	2.6		X Walk 2 X Slope (%)	N/A

N/A	Ramp inside XWalk1?	N/A	N/A	Ramp inside XWalk2?	N/A
	Road Slope (%)	N/A	N/A	Clear Space?	N/A
	Road X Slope (%)	N/A	N/A	Clear Space to XWalk (in)	N/A
N/A	Any Obstructions?	N/A	N/A	Storm Grate/Utility Hazard?	N/A
	Obstruction Type			Storm Grate/Utility Type	
		N/A			N/A
			Yes	Surface Condition? (G/P)	Good

Remove & Replace Entire Ramp.

Total Cost: \$ 1850.00
