Access Compliance Report

Public Rights-of-Way

(Curb Ramps)

Intersection ID: N/A	Main Street: CANTERBURY_CASTLE_DR	Cross Street: SAGMORE_HILL_DR	Location: NE
ADA ID: 9E1AF51ED72E	Ramp Type: Perp	Initial Pass/Fail: Fail	Overall Compliance: No
Severity Score: 46.25			
Codes/Mitigation Info/Possible Solution		Field Measurements/Component Compliance

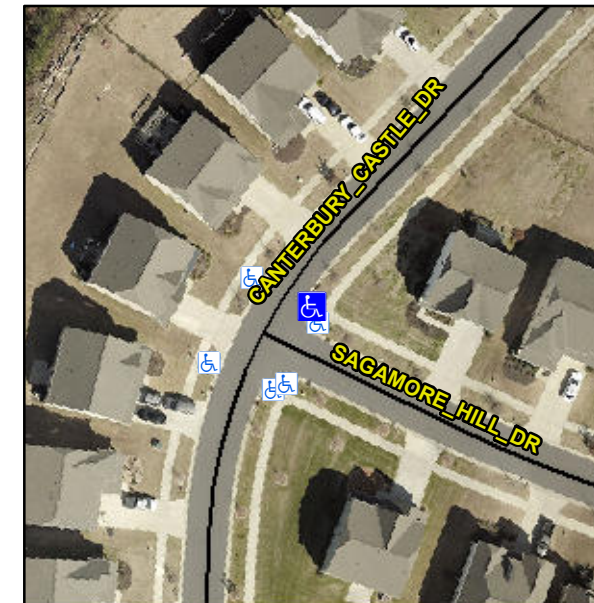
R304.5.1, R304.2.2, R304.5.3

Compliance	Description	Data	Compliance	Description	Data
N/A	Ramp Length (in)	96.0	No	Ramp Slope (%)	8.8
No	Ramp Width (in)	47.0	No	Ramp XSlope (%)	12.0
N/A	Flare Type LT	N/A	N/A	Flare Type RT	N/A
N/A	Flare Slope LT (%)	N/A	N/A	Flare Slope RT (%)	N/A
N/A	Flare Traversable LT?	N/A	N/A	Flare Traversable RT?	N/A
N/A	Landing Length (in)	N/A	N/A	DWS Provided?	N/A
N/A	Landing Width (in)	N/A	N/A	DWS Contrast?	N/A
N/A	Landing Slope (%)	N/A	N/A	DWS Length (in)	N/A
N/A	Landing X Slope (%)	N/A	N/A	DWS Full Width?	N/A
N/A	Landing Curb? (Y/N)	N/A	N/A	DWS Offset (in)	N/A
N/A	Shared Landing?	N/A			
N/A	Gutter Ponding?	N/A	N/A	Gutter Slope (%)	N/A
N/A	Gutter Lip Ht (in)	N/A	N/A	Gutter X Slope (%)	N/A
N/A	Painted X Walk1?	No	N/A	Painted X Walk2?	N/A
	X Walk 1 Direction	To NW		X Walk 2 Direction	N/A
N/A	X Walk 1 Width (in)	N/A	N/A	X Walk 2 Width (in)	N/A
	X Walk 1 Slope (%)	3.2		X Walk 2 Slope (%)	N/A
	X Walk 1 X Slope (%)	1.8		X Walk 2 X Slope (%)	N/A

Remove & Replace Entire Ramp.

Total Cost: \$ 1850.00
