Access Compliance Report

Public Rights-of-Way

(Curb Ramps)

Intersection ID: N/A	Main Street: SOUTHGROVE_ST	Cross Street: WAVERLY_CENTER_DR	Location: NW
ADA ID: 9E32E2F8274F	Ramp Type: Perp	Initial Pass/Fail: Fail	Overall Compliance: No
Severity Score: 8.75			
Codes/Mitigation Info/Possible Solution		Field Measurements/Component Compliance

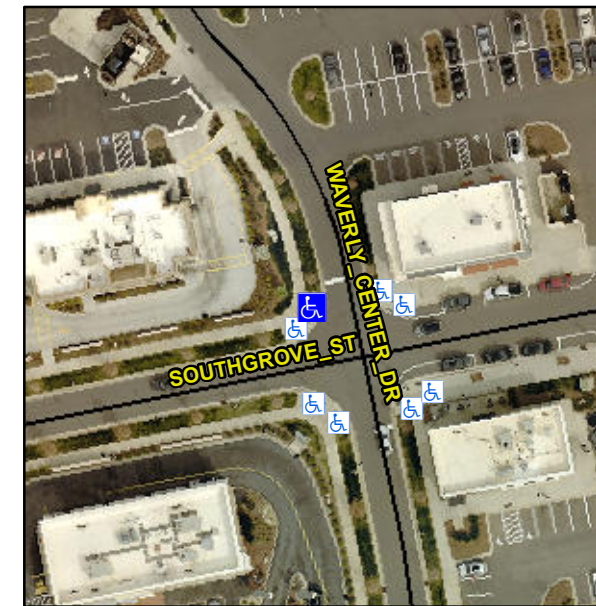
Compliance	Description	Data	Compliance	Description	Data
N/A	Ramp Length (in)	95.0	Yes	Ramp Slope (%)	7.1
No	Ramp Width (in)	47.0	Yes	Ramp XSlope (%)	0.3
N/A	Flare Type LT	N/A	N/A	Flare Type RT	N/A
N/A	Flare Slope LT (%)	N/A	N/A	Flare Slope RT (%)	N/A
N/A	Flare Traversable LT?	N/A	N/A	Flare Traversable RT?	N/A
N/A	Landing Length (in)	N/A	N/A	DWS Provided?	N/A
N/A	Landing Width (in)	N/A	N/A	DWS Contrast?	N/A
N/A	Landing Slope (%)	N/A	N/A	DWS Length (in)	N/A
N/A	Landing X Slope (%)	N/A	N/A	DWS Full Width?	N/A
N/A	Landing Curb? (Y/N)	N/A	N/A	DWS Offset (in)	N/A
N/A	Shared Landing?	N/A			
N/A	Gutter Ponding?	N/A	N/A	Gutter Slope (%)	N/A
N/A	Gutter Lip Ht (in)	N/A	N/A	Gutter X Slope (%)	N/A
N/A	Painted X Walk1?	No	N/A	Painted X Walk2?	N/A
	X Walk 1 Direction	To E		X Walk 2 Direction	N/A
N/A	X Walk 1 Width (in)	N/A	N/A	X Walk 2 Width (in)	N/A
	X Walk 1 Slope (%)	2.3		X Walk 2 Slope (%)	N/A
	X Walk 1 X Slope (%)	2.6		X Walk 2 X Slope (%)	N/A

Remove & Replace Entire Ramp.

R304.5.1

\$ 1850.00

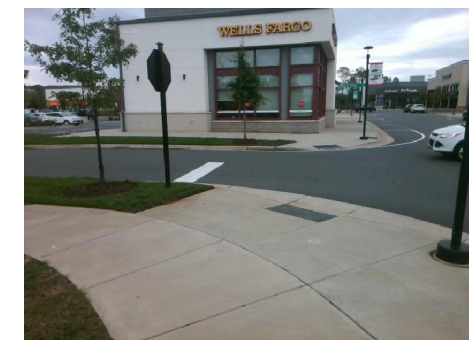
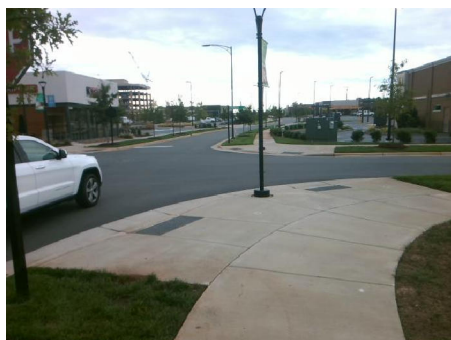
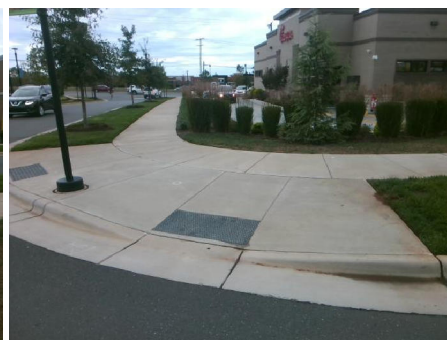
N/A	Ramp inside XWalk1?	N/A	N/A	Ramp inside XWalk2?	N/A
	Road Slope (%)	N/A	N/A	Clear Space?	N/A
	Road X Slope (%)	N/A	N/A	Clear Space to XWalk (in)	N/A
N/A	Any Obstructions?	N/A	N/A	Storm Grate/Utility Hazard?	N/A
	Obstruction Type			Storm Grate/Utility Type	
		N/A			N/A
		Yes		Surface Condition? (G/P)	Good
