Access Compliance Report

Public Rights-of-Way

(Curb Ramps)

Intersection ID: 6798	Main Street: OAKWOOD_DR	Cross Street: STATESVILLE_RD	Location: NW
ADA ID: 9E3AD615720E	Ramp Type: Para	Initial Pass/Fail: Fail	Overall Compliance: No
Severity Score: 12.5			
Codes/Mitigation Info/Possible Solution		Field Measurements/Component Compliance

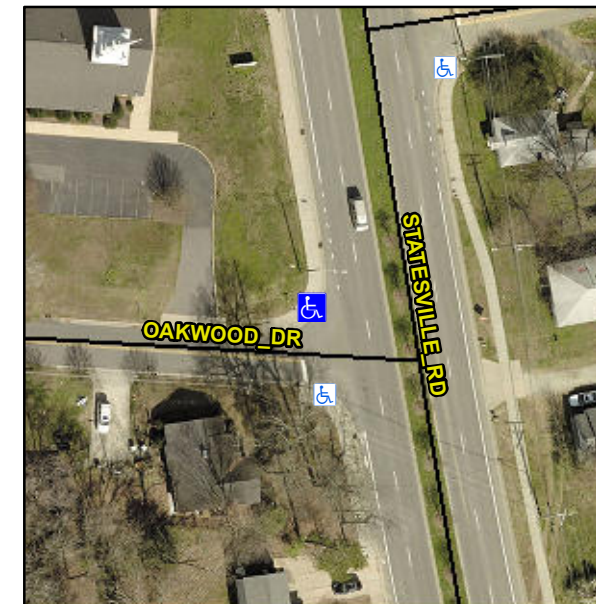
Compliance	Description	Data	Compliance	Description	Data
N/A	Ramp Length LT (in)	47.0	N/A	Ramp Length RT (in)	46.0
Yes	Ramp Width LT (in)	83.5	Yes	Ramp Width RT (in)	84.0
Yes	Ramp Slope LT (%)	5.2	No	Ramp Slope RT (%)	9.4
Yes	Ramp XSlope LT (%)	1.1	Yes	Ramp XSlope RT (%)	1.5
N/A	Landing Length (in)	N/A	N/A	DWS Provided?	N/A
N/A	Landing Width (in)	N/A	N/A	DWS Contrast?	N/A
N/A	Landing Slope (%)	N/A	N/A	DWS Length (in)	N/A
N/A	Landing X Slope (%)	N/A	N/A	DWS Full Width?	N/A
N/A	Landing Curb? (Y/N)	N/A	N/A	DWS Offset (in)	N/A
N/A	Shared Landing?	N/A			
N/A	Gutter Ponding?	N/A	N/A	Gutter Slope (%)	N/A
N/A	Gutter Lip Ht (in)	N/A	N/A	Gutter X Slope (%)	N/A
N/A	Painted X Walk1?	No	N/A	Painted X Walk2?	N/A
	X Walk 1 Direction	To S		X Walk 2 Direction	N/A
N/A	X Walk 1 Width (in)	N/A	N/A	X Walk 2 Width (in)	N/A
	X Walk 1 Slope (%)	1.6		X Walk 2 Slope (%)	N/A
	X Walk 1 X Slope (%)	0.2		X Walk 2 X Slope (%)	N/A
N/A	Ramp inside XWalk1?	N/A	N/A	Ramp inside XWalk2?	N/A

Road Slope (%)	N/A	N/A	Clear Space?	N/A
	Road X Slope (%)	N/A	N/A	Clear Space to XWalk (in)	N/A
N/A	Any Obstructions?	N/A	N/A	Storm Grate/Utility Hazard?	N/A
	Obstruction Type			Storm Grate/Utility Type	
		N/A			N/A
			Yes	Surface Condition? (G/P)	Good
			N/A	Curb Slope (%)	N/A

Possible Solutions:

Remove & Replace Entire Ramp.

R304.3.2
