# Access Compliance Report

## Public Rights-of-Way

### (Curb Ramps)

| Intersection ID: 3270 | Main Street: BATTLE_CREEK_CT | Cross Street: OLD_TIMBER_RD | Location: S |

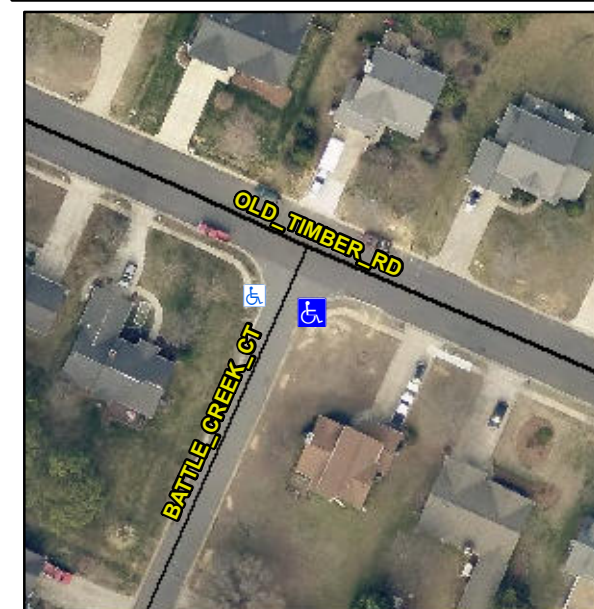
| ADA ID: 9E44062EC73F | Ramp Type: Perp | Initial Pass/Fail: Fail | Overall Compliance: No |
| Severity Score: 22.5 | | | |

**Not Found, R304.5.1, R304.2.2, R304.5.3**

| Compliance | Description | Data | Compliance | Description | Data |
|---|---|---|---|---|---|
| N/A | Ramp Length (in) | 57.0 | No | Ramp Slope (%) | 8.7 |
| No | Ramp Width (in) | 39.0 | No | Ramp XSlope (%) | 4.1 |

**Remove & Replace Entire Ramp.**
