Access Compliance Report

Public Rights-of-Way

(Curb Ramps)

Intersection ID: 12305	Main Street: E_5TH_ST	Cross Street: N_COLLEGE_ST	Location: S
ADA ID: 9E49D0837665	Ramp Type: BlendTrans1	Initial Pass/Fail: Pass	Overall Compliance: No
Severity Score: 0			
Codes/Mitigation Info/Possible Solution		Field Measurements/Component Compliance

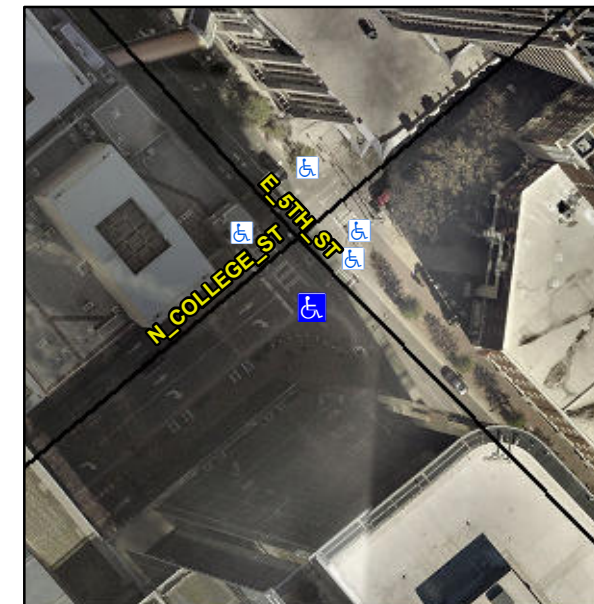
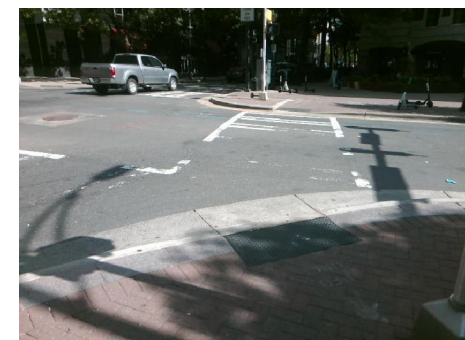
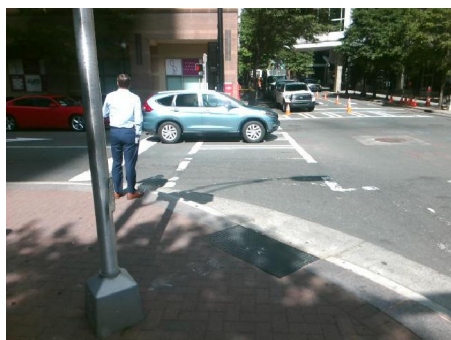
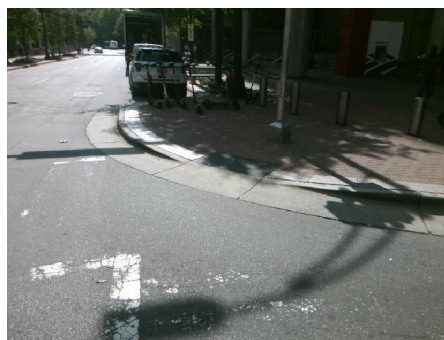
Not Found, R304.5.3

Compliance	Description	Data	Compliance	Description	Data
N/A	Ramp Length (in)	48.0	Yes	BlendTrans Slope (%)	0.7
Yes	Ramp Width (in)	48.0	Yes	BlendTrans XSlope (%)	0.2
N/A	Flare Type LT	Sloped	N/A	Flare Type RT	Sloped
Yes	Flare Slope LT (%)	4.4	Yes	Flare Slope RT (%)	8.4
N/A	Flare Traversable LT?	Yes	N/A	Flare Traversable RT?	Yes
Yes	Landing Length (in)	48.0	Yes	DWS Provided?	Yes
Yes	Landing Width (in)	48.0	Yes	DWS Contrast?	Yes
Yes	Landing Slope (%)	2.0	Yes	DWS Length (in)	24.0
No	Landing X Slope (%)	3.2	Yes	DWS Full Width?	Yes
N/A	Landing Curb? (Y/N)	No	Yes	DWS Offset (in)	0.0
N/A	Shared Landing?	No			
Yes	Gutter Ponding?	No	Yes	Gutter Slope (%)	1.2
Yes	Gutter Lip Ht (in)	0.0	Yes	Gutter X Slope (%)	0.1
N/A	Painted X Walk1?	Yes	N/A	Painted X Walk2?	Yes
	X Walk 1 Direction	To NE		X Walk 2 Direction	To NW
	X Walk 1 Width (in)	108.0		X Walk 2 Width (in)	109.0
	X Walk 1 Slope (%)	3.5		X Walk 2 Slope (%)	1.6
	X Walk 1 X Slope (%)	3.2		X Walk 2 X Slope (%)	0.1

Yes	Ramp inside XWalk1?	Yes	Yes	Ramp inside XWalk2?	Yes
	Road Slope (%)	2.3		Clear Space?	Yes
	Road X Slope (%)	2.4	No	Clear Space to XWalk (in)	24.0
Yes	Any Obstructions?	No	Yes	Storm Grate/Utility Hazard?	No
	Obstruction Type			Storm Grate/Utility Type	
		N/A			N/A
			Yes	Surface Condition? (G/P)	Good
			No	Curb Slope (%)	8.1

Remove & Replace Curb Ramp With Two New Directional Ramps or Equivalent. Restripe Crosswalk(s) To Provide Clear space.
