Access Compliance Report

Public Rights-of-Way

(Curb Ramps)

Intersection ID: 53183	Main Street: ARMSTRONG_PARK_DR	Cross Street: BASIE_PARK_CT	Location: SE
ADA ID: 9E5C5D51B1F0	Ramp Type: Perp	Initial Pass/Fail: Fail	Overall Compliance: No
Severity Score: 46.25			
Codes/Mitigation Info/Possible Solution		Field Measurements/Component Compliance

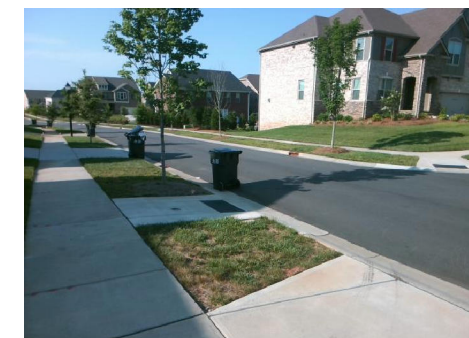
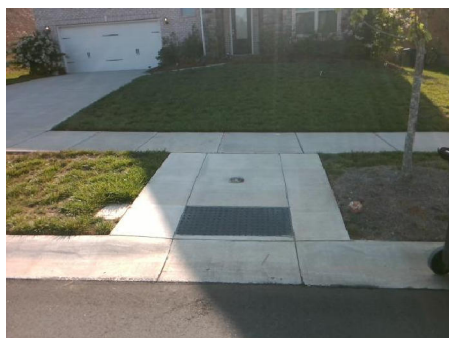
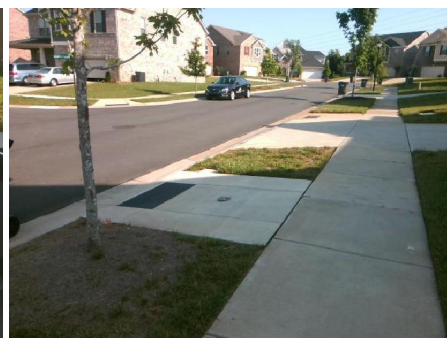
Not Found, R304.5.1, R304.2.2, R304.5.3

Compliance	Description	Data	Compliance	Description	Data
N/A	Ramp Length (in)	99.0	No	Ramp Slope (%)	9.2
No	Ramp Width (in)	46.0	No	Ramp XSlope (%)	7.3
N/A	Flare Type LT	N/A	N/A	Flare Type RT	N/A
N/A	Flare Slope LT (%)	N/A	N/A	Flare Slope RT (%)	N/A
N/A	Flare Traversable LT?	N/A	N/A	Flare Traversable RT?	N/A
N/A	Landing Length (in)	N/A	N/A	DWS Provided?	N/A
N/A	Landing Width (in)	N/A	N/A	DWS Contrast?	N/A
N/A	Landing Slope (%)	N/A	N/A	DWS Length (in)	N/A
N/A	Landing X Slope (%)	N/A	N/A	DWS Full Width?	N/A
N/A	Landing Curb? (Y/N)	N/A	N/A	DWS Offset (in)	N/A
N/A	Shared Landing?	N/A			
N/A	Gutter Ponding?	N/A	N/A	Gutter Slope (%)	N/A
N/A	Gutter Lip Ht (in)	N/A	N/A	Gutter X Slope (%)	N/A
N/A	Painted X Walk1?	No	N/A	Painted X Walk2?	N/A
	X Walk 1 Direction	To SW		X Walk 2 Direction	N/A
N/A	X Walk 1 Width (in)	N/A	N/A	X Walk 2 Width (in)	N/A
	X Walk 1 Slope (%)	3.5		X Walk 2 Slope (%)	N/A
	X Walk 1 X Slope (%)	3.6		X Walk 2 X Slope (%)	N/A

N/A	Ramp inside XWalk1?	N/A	N/A	Ramp inside XWalk2?	N/A
	Road Slope (%)	N/A	N/A	Clear Space?	N/A
	Road X Slope (%)	N/A	N/A	Clear Space to XWalk (in)	N/A
N/A	Any Obstructions?	N/A	N/A	Storm Grate/Utility Hazard?	N/A
	Obstruction Type			Storm Grate/Utility Type	
		N/A			N/A
			Yes	Surface Condition? (G/P)	Good

Remove & Replace Entire Ramp.
