# Access Compliance Report

## Public Rights-of-Way (Curb Ramps)

| Intersection ID: 50587 | Main Street: DOWNY_BIRCH_RD | Cross Street: GREAT_LAUREL_RD | Location: NW |
| ADA ID: 9E5E53BDF7A8 | Ramp Type: BlendTrans1 | Initial Pass/Fail: Fail | Overall Compliance: No |

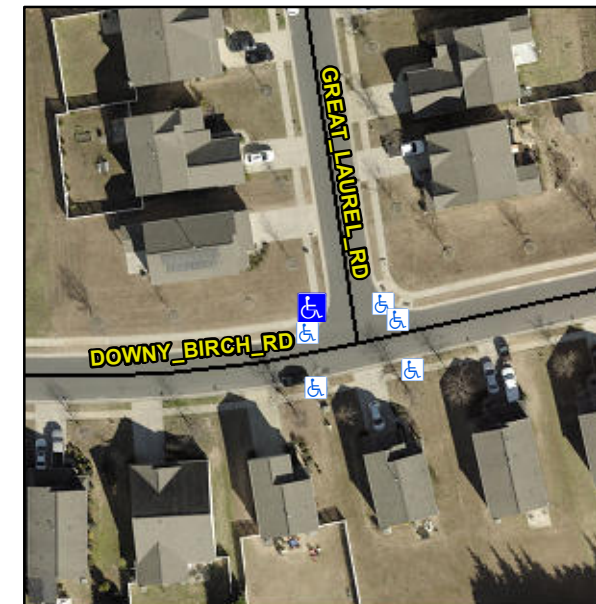
| Severity Score: 10 | | | |

**Not Found, R304.5.1, R304.5.3**

| Compliance | Description | Data | Compliance | Description | Data |
|---|---|---|---|---|---|
| No | Ramp Width (in) | 46.5 | No | BlendTrans XSlope (%) | 2.2 |

**Remove & Replace Curb Ramp With Two New Directional Ramps or Equivalent.**

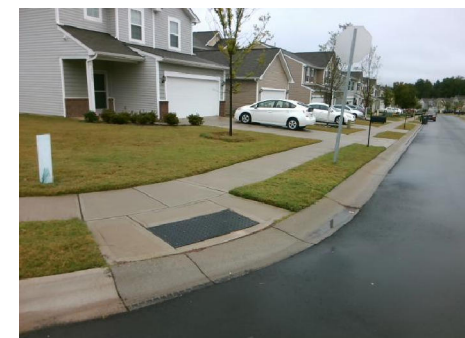
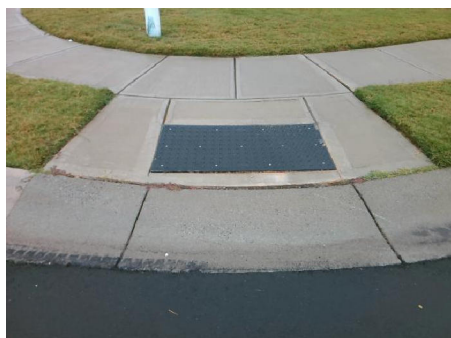
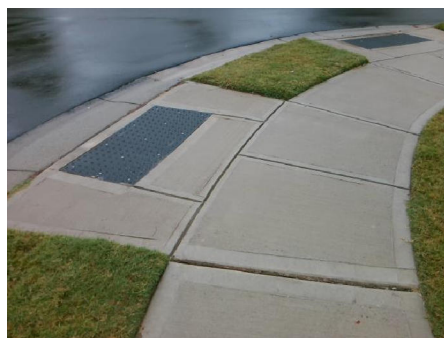
| Compliance | Description | Data | Compliance | Description | Data |
|---|---|---|---|---|---|
| | | | No | Curb Slope (%) | 8.9 |
