Access Compliance Report

Public Rights-of-Way

(Curb Ramps)

Intersection ID: 52518	Main Street: FRANKLIN_MEADOWS_DR	Cross Street: WEDDINGTON_RD	Location: SE
ADA ID: 9E60DA1D1CE2	Ramp Type: Perp	Initial Pass/Fail: Fail	Overall Compliance: No
Severity Score: 12.5			
Codes/Mitigation Info/Possible Solution		Field Measurements/Component Compliance

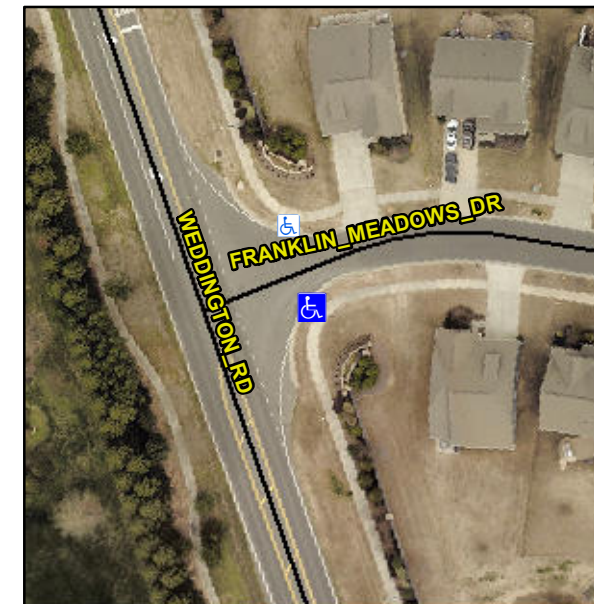
Compliance	Description	Data	Compliance	Description	Data
N/A	Ramp Length (in)	67.0	No	Ramp Slope (%)	8.6
Yes	Ramp Width (in)	59.0	Yes	Ramp XSlope (%)	0.1
N/A	Flare Type LT	N/A	N/A	Flare Type RT	N/A
N/A	Flare Slope LT (%)	N/A	N/A	Flare Slope RT (%)	N/A
N/A	Flare Traversable LT?	N/A	N/A	Flare Traversable RT?	N/A
N/A	Landing Length (in)	N/A	N/A	DWS Provided?	N/A
N/A	Landing Width (in)	N/A	N/A	DWS Contrast?	N/A
N/A	Landing Slope (%)	N/A	N/A	DWS Length (in)	N/A
N/A	Landing X Slope (%)	N/A	N/A	DWS Full Width?	N/A
N/A	Landing Curb? (Y/N)	N/A	N/A	DWS Offset (in)	N/A
N/A	Shared Landing?	N/A			
N/A	Gutter Ponding?	N/A	N/A	Gutter Slope (%)	N/A
N/A	Gutter Lip Ht (in)	N/A	N/A	Gutter X Slope (%)	N/A
N/A	Painted X Walk1?	No	N/A	Painted X Walk2?	N/A
	X Walk 1 Direction	To N		X Walk 2 Direction	N/A
N/A	X Walk 1 Width (in)	N/A	N/A	X Walk 2 Width (in)	N/A
	X Walk 1 Slope (%)	0.2		X Walk 2 Slope (%)	N/A
	X Walk 1 X Slope (%)	0.9		X Walk 2 X Slope (%)	N/A

N/A	Ramp inside XWalk1?	N/A	N/A	Ramp inside XWalk2?	N/A
	Road Slope (%)	N/A	N/A	Clear Space?	N/A
	Road X Slope (%)	N/A	N/A	Clear Space to XWalk (in)	N/A
N/A	Any Obstructions?	N/A	N/A	Storm Grate/Utility Hazard?	N/A
	Obstruction Type			Storm Grate/Utility Type	
		N/A			N/A
			Yes	Surface Condition? (G/P)	Good

Possible Solutions:

Remove & Replace Entire Ramp.
