Access Compliance Report

Public Rights-of-Way

(Curb Ramps)

Intersection ID: 49252	Main Street: ROCKLAND_DR	Cross Street: BROOKE_NICOLE_PL	Location: S
ADA ID: 9E7455C3BC37	Ramp Type: PerpDiag	Initial Pass/Fail: Pass	Overall Compliance: No
Severity Score: 5.25			
Codes/Mitigation Info/Possible Solution		Field Measurements/Component Compliance

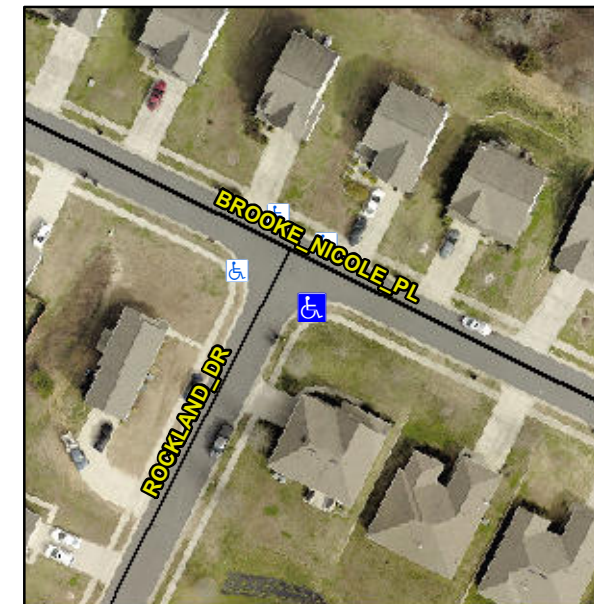
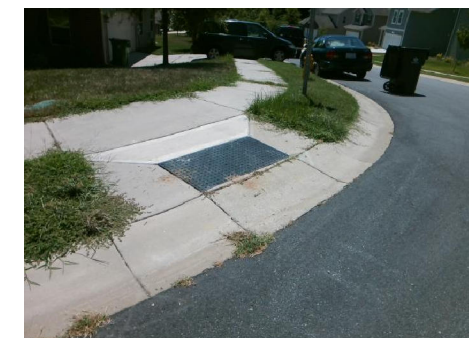
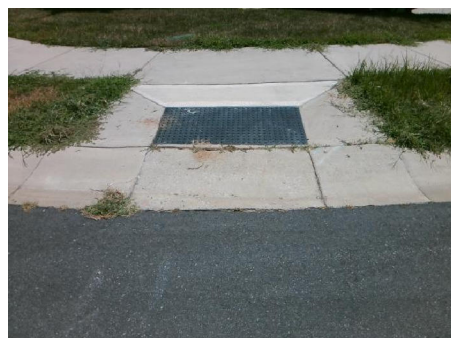
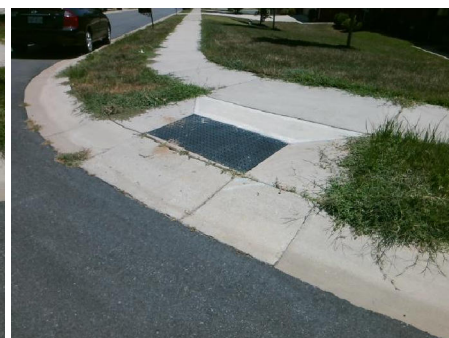
Not Found, R304.5.3, R305.2, R304.5.4

Compliance	Description	Data	Compliance	Description	Data
N/A	Ramp Length (in)	48.0	Yes	Ramp Slope (%)	5.1
Yes	Ramp Width (in)	48.0	No	Ramp XSlope (%)	4.0
N/A	Flare Type LT	Sloped	N/A	Flare Type RT	N/A
N/A	Flare Slope LT (%)	7.0	N/A	Flare Slope RT (%)	4.4
N/A	Flare Traversable LT?	No	N/A	Flare Traversable RT?	No
Yes	Landing Length (in)	48.0	Yes	DWS Provided?	Yes
Yes	Landing Width (in)	77.0	Yes	DWS Contrast?	Yes
Yes	Landing Slope (%)	0.9	Yes	DWS Length (in)	24.5
No	Landing X Slope (%)	5.6	Yes	DWS Full Width?	Yes
N/A	Landing Curb? (Y/N)	No	No	DWS Offset (in)	3.0
N/A	Shared Landing?	No			
Yes	Gutter Ponding?	No	No	Gutter Slope (%)	7.8
Yes	Gutter Lip Ht (in)	0.0	No	Gutter X Slope (%)	2.1
N/A	Painted X Walk1?	No	N/A	Painted X Walk2?	No
	X Walk 1 Direction	To E		X Walk 2 Direction	To W
N/A	X Walk 1 Width (in)	N/A	N/A	X Walk 2 Width (in)	N/A
	X Walk 1 Slope (%)	3.6		X Walk 2 Slope (%)	5.4
	X Walk 1 X Slope (%)	10.3		X Walk 2 X Slope (%)	5.1

N/A	Ramp inside XWalk1?	N/A	N/A	Ramp inside XWalk2?	N/A
	Road Slope (%)	2.4	N/A	Clear Space?	Yes
	Road X Slope (%)	7.5	N/A	Clear Space to XWalk (in)	N/A
Yes	Any Obstructions?	No	Yes	Storm Grate/Utility Hazard?	No
	Obstruction Type			Storm Grate/Utility Type	
		N/A			N/A
		Yes	Yes	Surface Condition? (G/P)	Good

Possible Solutions:

Remove & Replace Curb Ramp With Two New Directional Ramps or Equivalent. Remove & Replace Gutter.
