## Access Compliance Report Public Rights-of-Way (Curb Ramps)

Intersection ID: 30004	Main Str	Cross Street: MANDY_PLACE_CT					Location:	NE		
ADA ID: 9E830C88FE5E	Ramp Ty	Ramp Type: PerpDiag			I: Fail Overall C	o Severity Score:	33.75			
Codes/Mitigation Info/Possible Solution				Field Measurements/Component Compliance

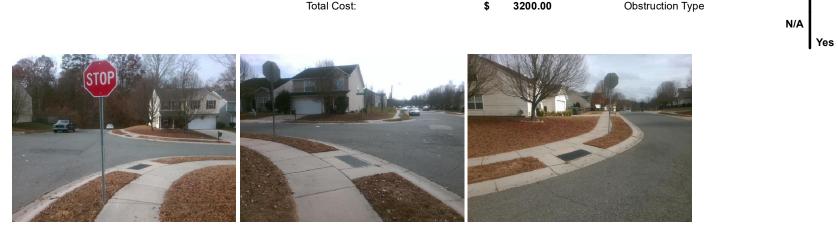
1.2	Possible Solutions:	Compliance Description			Data	Data Compliance Description			
	ACCEL OFF	Remove & Replace Curb Ramp W	ith N/	A	Ramp Length (in)	46.5	No	Ramp Slope (%)	9.2	
		Two New Directional Ramps or	No	<b>b</b>	Ramp Width (in)	42.5	No	Ramp XSlope (%)	6.2	
		Equivalent.	N/	Α	Flare Type LT	N/A	N/A	Flare Type RT	N/A	
			N/	Α	Flare Slope LT (%)	N/A	N/A	Flare Slope RT (%)	N/A	
			N/	Α	Flare Traversable LT?	N/A	N/A	Flare Traversable RT?	N/A	
			N/	Α	Landing Length (in)	N/A	N/A	DWS Provided?	N/A	
		Surveyor Notes:	N/	Α	Landing Width (in)	N/A	N/A	DWS Contrast?	N/A	
		N/A	N/	Α	Landing Slope (%)	N/A	N/A	DWS Length (in)	N/A	
MANDY PLAG			N/	Α	Landing X Slope (%)	N/A	N/A	DWS Full Width?	N/A	
			N/		Landing Curb? (Y/N)	N/A	N/A	DWS Offset (in)	N/A	
			N/	Α	Shared Landing?	N/A				
	TTY Y	PROW/ADA:	N/	Α	Gutter Ponding?	N/A	N/A	Gutter Slope (%)	N/A	
		Not Found, R304.5.1, R304.2.2,	N/	Α	Gutter Lip Ht (in)	N/A	N/A	Gutter X Slope (%)	N/A

R304.5.3	N/	Α	Painted X Walk1?	No	N/A	Painted X Walk2?	No	
					X Walk 1 Direction	To W		X Walk 2 Direction	To S	
	Serve -		N/	Α	X Walk 1 Width (in)	N/A	N/A	X Walk 2 Width (in)	N/A	
Street 1 Name	DAY LILLY LN	-			X Walk 1 Slope (%)	2.5		X Walk 2 Slope (%)	5.7	
Stop Condition-Street 2	None				X Walk 1 X Slope (%)	5.3		X Walk 2 X Slope (%)	2.0	
Street 2 Name	MANDY PL CT		N/	Α	Ramp inside XWalk1?	N/A	N/A	Ramp inside XWalk2?	N/A	
Stop Condition-Street 1	StopSign				Road Slope (%)	6.0	N/A	Clear Space?	N/A	
					Road X Slope (%)	3.6	N/A	Clear Space to XWalk (in)	N/A	
			N		Any Obstructions?		N/A	Storm Grate/Utility Hazard?	N/A	
		Total Cost: \$ 32	00.00		Obstruction Type			Storm Grate/Utility Type
