Access Compliance Report

Public Rights-of-Way

(Curb Ramps)

Intersection ID: 25971	Main Street: CARMEL COMMONS BV	Cross Street: EL GRECO CT	Location: NW
ADA ID: 9E86503A11B0	Ramp Type: PerpDiag	Initial Pass/Fail: Fail	Overall Compliance: No
		Severity Score: 12.5

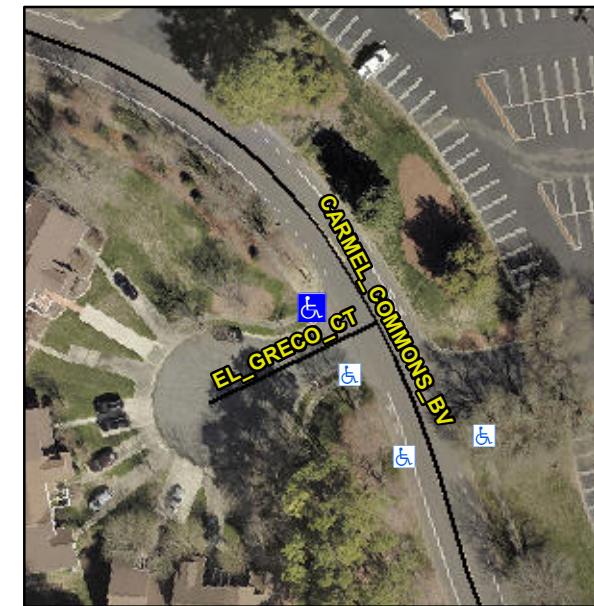
Compliance	Description	Data	Compliance	Description	Data
N/A	Ramp Length (in)	91.0	Yes	Ramp Slope (%)	7.1
Yes	Ramp Width (in)	56.0	No	Ramp XSlope (%)	6.0
N/A	Flare Type LT	N/A	N/A	Flare Type RT	N/A
N/A	Flare Slope LT (%)	N/A	N/A	Flare Slope RT (%)	N/A
N/A	Flare Traversable LT?	N/A	N/A	Flare Traversable RT?	N/A
N/A	Landing Length (in)	N/A	N/A	DWS Provided?	N/A
N/A	Landing Width (in)	N/A	N/A	DWS Contrast?	N/A
N/A	Landing Slope (%)	N/A	N/A	DWS Length (in)	N/A
N/A	Landing X Slope (%)	N/A	N/A	DWS Full Width?	N/A
N/A	Landing Curb? (Y/N)	N/A	N/A	DWS Offset (in)	N/A
N/A	Shared Landing?	N/A			
N/A	Gutter Ponding?	N/A	N/A	Gutter Slope (%)	N/A
N/A	Gutter Lip Ht (in)	N/A	N/A	Gutter X Slope (%)	N/A
N/A	Painted X Walk1?	No	N/A	Painted X Walk2?	No
	X Walk 1 Direction	To S		X Walk 2 Direction	To E
N/A	X Walk 1 Width (in)	N/A	N/A	X Walk 2 Width (in)	N/A
	X Walk 1 Slope (%)	1.3		X Walk 2 Slope (%)	4.2
	X Walk 1 X Slope (%)	1.6		X Walk 2 X Slope (%)	5.5

N/A	Ramp inside XWalk1?	N/A	N/A	Ramp inside XWalk2?	N/A
	Road Slope (%)	4.1	N/A	Clear Space?	N/A
	Road X Slope (%)	3.1	N/A	Clear Space to XWalk (in)	N/A
N/A	Any Obstructions?	N/A	N/A	Storm Grate/Utility Hazard?	N/A
	Obstruction Type			Storm Grate/Utility Type	
		N/A			N/A
		Yes		Surface Condition? (G/P)	Good

Remove & Replace Curb Ramp With Two New Directional Ramps or Equivalent.

R304.5.3

Total Cost: \$ 3200.00
