Access Compliance Report

Public Rights-of-Way

(Curb Ramps)

Intersection ID: 46304	Main Street: AUGUSTINE_WY	Cross Street: MERMANS_RD	Location: NW
ADA ID: 9E8D30FB2840	Ramp Type: PerpDiag	Initial Pass/Fail: Fail	Overall Compliance: No
		Severity Score: 22.5

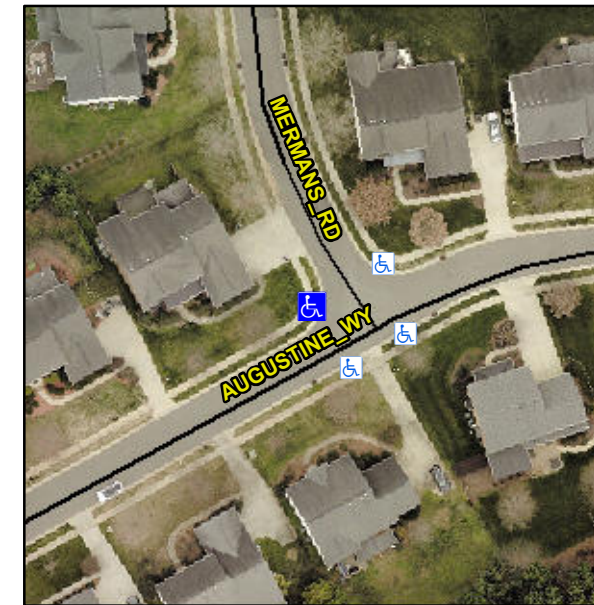
Not Found, R304.5.1, R304.2.2, R304.5.3

Compliance	Description	Data	Compliance	Description	Data
N/A	Ramp Length (in)	46.0	No	Ramp Slope (%)	8.6
No	Ramp Width (in)	40.0	No	Ramp XSlope (%)	2.5
N/A	Flare Type LT	N/A	N/A	Flare Type RT	N/A
N/A	Flare Slope LT (%)	N/A	N/A	Flare Slope RT (%)	N/A
N/A	Flare Traversable LT?	N/A	N/A	Flare Traversable RT?	N/A
N/A	Landing Length (in)	N/A	N/A	DWS Provided?	N/A
N/A	Landing Width (in)	N/A	N/A	DWS Contrast?	N/A
N/A	Landing Slope (%)	N/A	N/A	DWS Length (in)	N/A
N/A	Landing X Slope (%)	N/A	N/A	DWS Full Width?	N/A
N/A	Landing Curb? (Y/N)	N/A	N/A	DWS Offset (in)	N/A
N/A	Shared Landing?	N/A			
N/A	Gutter Ponding?	N/A	N/A	Gutter Slope (%)	N/A
N/A	Gutter Lip Ht (in)	N/A	N/A	Gutter X Slope (%)	N/A
N/A	Painted X Walk1?	No	N/A	Painted X Walk2?	No
	X Walk 1 Direction	To S		X Walk 2 Direction	To E
N/A	X Walk 1 Width (in)	N/A	N/A	X Walk 2 Width (in)	N/A
	X Walk 1 Slope (%)	7.2		X Walk 2 Slope (%)	4.3
	X Walk 1 X Slope (%)	1.7		X Walk 2 X Slope (%)	6.6

N/A	Ramp inside XWalk1?	N/A	N/A	Ramp inside XWalk2?	N/A
	Road Slope (%)	3.0	N/A	Clear Space?	N/A
	Road X Slope (%)	8.6	N/A	Clear Space to XWalk (in)	N/A
N/A	Any Obstructions?	N/A	N/A	Storm Grate/Utility Hazard?	N/A
	Obstruction Type			Storm Grate/Utility Type	
		N/A			N/A
			Yes	Surface Condition? (G/P)	Good

Remove & Replace Curb Ramp With Two New Directional Ramps or Equivalent.

Total Cost: \$ 3200.00
