# Access Compliance Report

## Public Rights-of-Way

| Intersection ID: 50272 | Main Street: SOUTH_BV | Cross Street: WHITTON_ST | Location: SW |
| ADA ID: 9E93B19FE900 | Ramp Type: BlendTrans1 | Initial Pass/Fail: Pass | Overall Compliance: No |

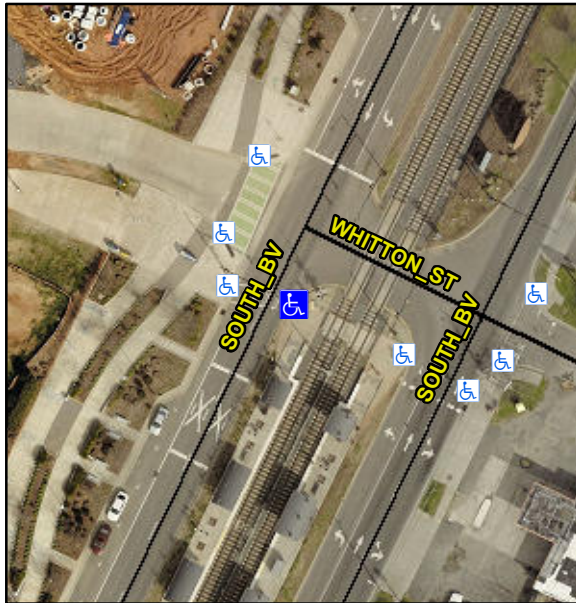
Surveyor Notes:

**N/A**

PROW/ADA:

**R305.1.4**

| Compliance | Description | Data | Compliance | Description | Data |
|---|---|---|---|---|---|
| Yes | Landing X Slope (%) | 1.3 | No | DWS Full Width? | No |

Possible Solutions:

**Remove & Replace Detectable Warning System.**

Total Cost: \$ 800.00
