Access Compliance Report

Public Rights-of-Way

(Curb Ramps)

Intersection ID: 11958	Main Street: E_16TH_ST	Cross Street: SEIGLE_AV	Location: E
ADA ID: 9E9CE49B4CB4	Ramp Type: Perp	Initial Pass/Fail: Fail	Overall Compliance: No
			Severity Score: 21.25

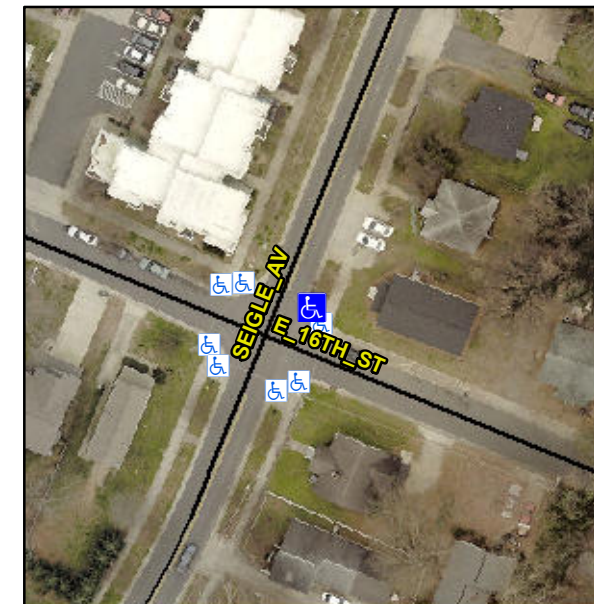
R304.5.1, R304.2.2

Compliance	Description	Data	Compliance	Description	Data
N/A	Ramp Length (in)	64.0	No	Ramp Slope (%)	9.9
No	Ramp Width (in)	47.0	Yes	Ramp XSlope (%)	0.3
N/A	Flare Type LT	N/A	N/A	Flare Type RT	N/A
N/A	Flare Slope LT (%)	N/A	N/A	Flare Slope RT (%)	N/A
N/A	Flare Traversable LT?	N/A	N/A	Flare Traversable RT?	N/A
N/A	Landing Length (in)	N/A	N/A	DWS Provided?	N/A
N/A	Landing Width (in)	N/A	N/A	DWS Contrast?	N/A
N/A	Landing Slope (%)	N/A	N/A	DWS Length (in)	N/A
N/A	Landing X Slope (%)	N/A	N/A	DWS Full Width?	N/A
N/A	Landing Curb? (Y/N)	N/A	N/A	DWS Offset (in)	N/A
N/A	Shared Landing?	N/A			
N/A	Gutter Ponding?	Yes	N/A	Gutter Slope (%)	N/A
N/A	Gutter Lip Ht (in)	N/A	N/A	Gutter X Slope (%)	N/A
N/A	Painted X Walk1?	No	N/A	Painted X Walk2?	N/A
	X Walk 1 Direction	To NW		X Walk 2 Direction	N/A
N/A	X Walk 1 Width (in)	N/A	N/A	X Walk 2 Width (in)	N/A
	X Walk 1 Slope (%)	1.0		X Walk 2 Slope (%)	N/A
	X Walk 1 X Slope (%)	1.4		X Walk 2 X Slope (%)	N/A

Remove & Replace Entire Ramp.
