# Access Compliance Report

## Public Rights-of-Way

| Intersection ID: 11512 | Main Street: N_SMITH_ST | Cross Street: W_7TH_ST | Location: S |
| ADA ID: 9EA116FD1026 | Ramp Type: BlendTrans1 | Initial Pass/Fail: Fail | Overall Compliance: No |

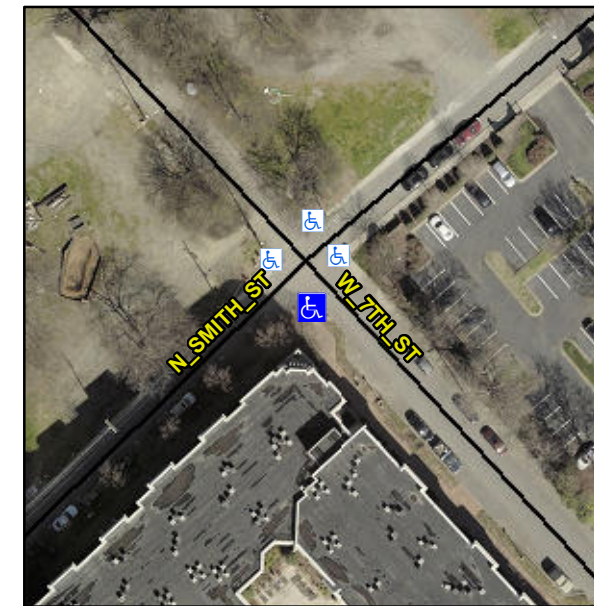
**CURB LIP 1.5**

**Not Found, R304.5.1, R304.5.3**

| Compliance | Description | Data | Compliance | Description | Data |
|---|---|---|---|---|---|
| No | Ramp Width (in) | 44.0 | No | BlendTrans XSlope (%) | 2.3 |

**Remove & Replace Curb Ramp With Two New Directional Ramps or Equivalent.**
