Access Compliance Report

Public Rights-of-Way

(Curb Ramps)

Intersection ID: N/A	Main Street: CANTERBURY_CASTLE_DR	Cross Street: SPRINGWOOD_ESTATE_DR	Location: SW
ADA ID: 9EA768A0032B	Ramp Type: Perp	Initial Pass/Fail: Fail	Overall Compliance: No
Severity Score: 21.25			
Codes/Mitigation Info/Possible Solution		Field Measurements/Component Compliance

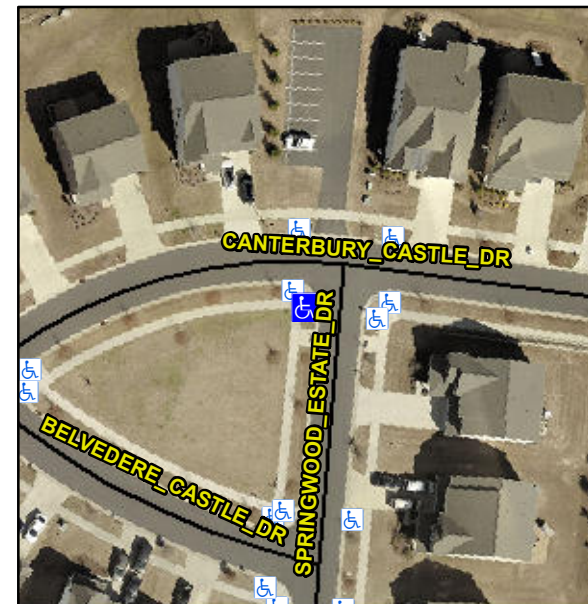
Not Found, R304.5.1, R304.5.3

Compliance	Description	Data	Compliance	Description	Data
N/A	Ramp Length (in)	96.0	Yes	Ramp Slope (%)	8.2
No	Ramp Width (in)	46.5	No	Ramp XSlope (%)	5.3
N/A	Flare Type LT	N/A	N/A	Flare Type RT	N/A
N/A	Flare Slope LT (%)	N/A	N/A	Flare Slope RT (%)	N/A
N/A	Flare Traversable LT?	N/A	N/A	Flare Traversable RT?	N/A
N/A	Landing Length (in)	N/A	N/A	DWS Provided?	N/A
N/A	Landing Width (in)	N/A	N/A	DWS Contrast?	N/A
N/A	Landing Slope (%)	N/A	N/A	DWS Length (in)	N/A
N/A	Landing X Slope (%)	N/A	N/A	DWS Full Width?	N/A
N/A	Landing Curb? (Y/N)	N/A	N/A	DWS Offset (in)	N/A
N/A	Shared Landing?	N/A			
N/A	Gutter Ponding?	N/A	N/A	Gutter Slope (%)	N/A
N/A	Gutter Lip Ht (in)	N/A	N/A	Gutter X Slope (%)	N/A
N/A	Painted X Walk1?	No	N/A	Painted X Walk2?	N/A
	X Walk 1 Direction	To SE		X Walk 2 Direction	N/A
N/A	X Walk 1 Width (in)	N/A	N/A	X Walk 2 Width (in)	N/A
	X Walk 1 Slope (%)	3.9		X Walk 2 Slope (%)	N/A
	X Walk 1 X Slope (%)	0.6		X Walk 2 X Slope (%)	N/A

N/A	Ramp inside XWalk1?	N/A	N/A	Ramp inside XWalk2?	N/A
	Road Slope (%)	N/A	N/A	Clear Space?	N/A
	Road X Slope (%)	N/A	N/A	Clear Space to XWalk (in)	N/A
N/A	Any Obstructions?	N/A	N/A	Storm Grate/Utility Hazard?	N/A
	Obstruction Type			Storm Grate/Utility Type	
		N/A			N/A
		Yes		Surface Condition? (G/P)	Good

Possible Solutions:

Remove & Replace Entire Ramp.
