Intersection ID: N/A	Main Street: CAROLINA_CROSSING_DR	Cross Street: SHADOW_RIDGE_LN	Location:	NE
ADA ID: 9EA8C3AD29BA	Ramp Type: PerpDiag	Initial Pass/Fail: Fail	Overall Compliance: No	Severity Score: 25

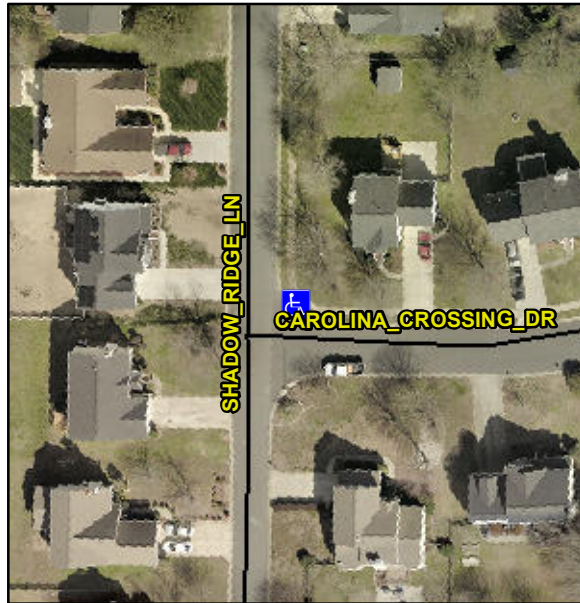
Compliance	Description	Data	Compliance	Description	Data
N/A	Ramp Length (in)	46.0	No	Ramp Slope (%)	12.4
Yes	Ramp Width (in)	48.0	Yes	Ramp XSlope (%)	0.1
N/A	Flare Type LT	N/A	N/A	Flare Type RT	N/A
N/A	Flare Slope LT (%)	N/A	N/A	Flare Slope RT (%)	N/A
N/A	Flare Traversable LT?	N/A	N/A	Flare Traversable RT?	N/A
N/A	Landing Length (in)	N/A	N/A	DWS Provided?	N/A
N/A	Landing Width (in)	N/A	N/A	DWS Contrast?	N/A
N/A	Landing Slope (%)	N/A	N/A	DWS Length (in)	N/A
N/A	Landing X Slope (%)	N/A	N/A	DWS Full Width?	N/A
N/A	Landing Curb? (Y/N)	N/A	N/A	DWS Offset (in)	N/A
N/A	Shared Landing?	N/A			
N/A	Gutter Ponding?	N/A	N/A	Gutter Slope (%)	N/A
N/A	Gutter Lip Ht (in)	N/A	N/A	Gutter X Slope (%)	N/A
N/A	Painted X Walk1?	No	N/A	Painted X Walk2?	No
	X Walk 1 Direction	To W		X Walk 2 Direction	To S
N/A	X Walk 1 Width (in)	N/A	N/A	X Walk 2 Width (in)	N/A
	X Walk 1 Slope (%)	0.2		X Walk 2 Slope (%)	0.7
	X Walk 1 X Slope (%)	0.1		X Walk 2 X Slope (%)	0.1

N/A	Ramp inside XWalk1?	N/A	N/A	Ramp inside XWalk2?	N/A
	Road Slope (%)	0.0	N/A	Clear Space?	N/A
	Road X Slope (%)	1.9	N/A	Clear Space to XWalk (in)	N/A
N/A	Any Obstructions?	N/A	N/A	Storm Grate/Utility Hazard?	N/A
	Obstruction Type			Storm Grate/Utility Type	
		N/A			N/A
			Yes	Surface Condition? (G/P)	Good

**Remove & Replace Curb Ramp With Two New Directional Ramps or Equivalent.**

### R304.2.2

Total Cost: \$ 3200.00
